ENERGY AUDIT REPORT

Maldives Meteorological
Services' Gan Office

Promoting Energy Efficient Buildings through
Strengthening Low Carbon Energy
Island Strategies (LCEI) Project

November 2020

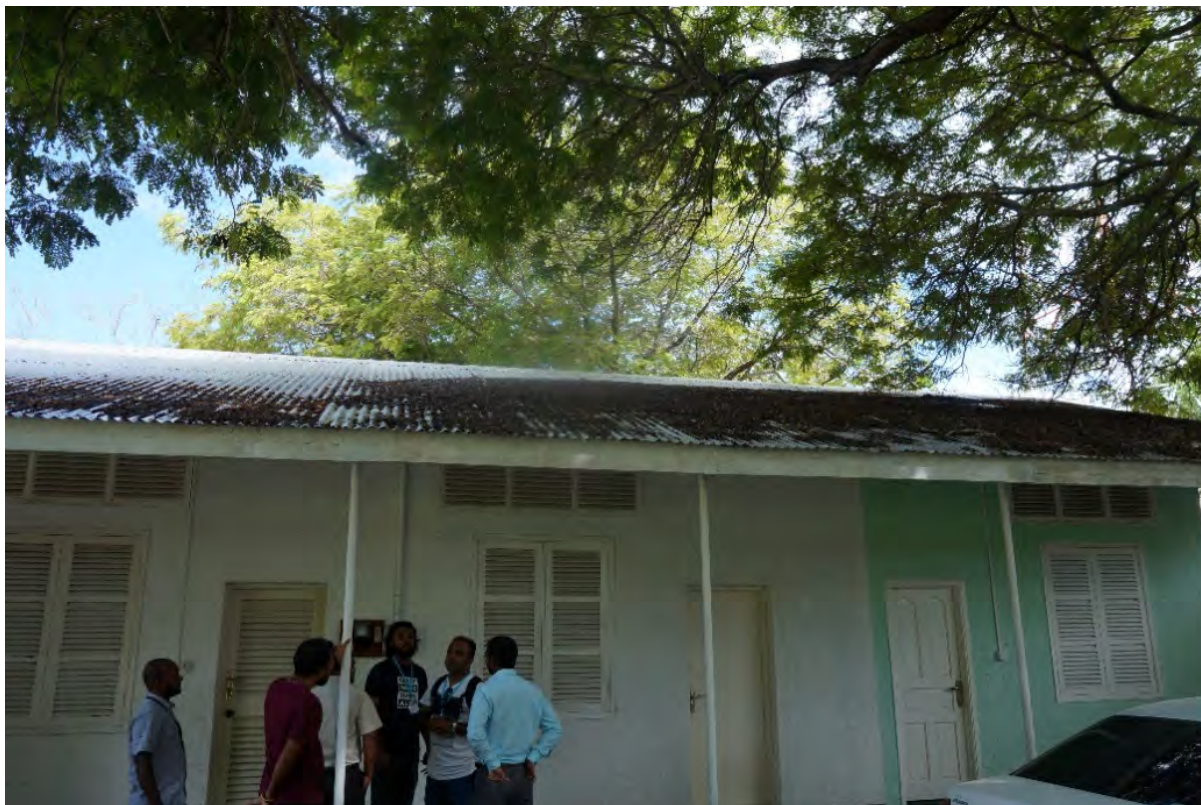
Figure 1: Accommodation block

The MET office accommodation is a room and adjacent ensuite to provide temporary accommodation for office workers required to remain at or nearby to the met office overnight. The room is part of a block of similar accommodation units and contains very simple lighting, air conditioning and ablution facilities.

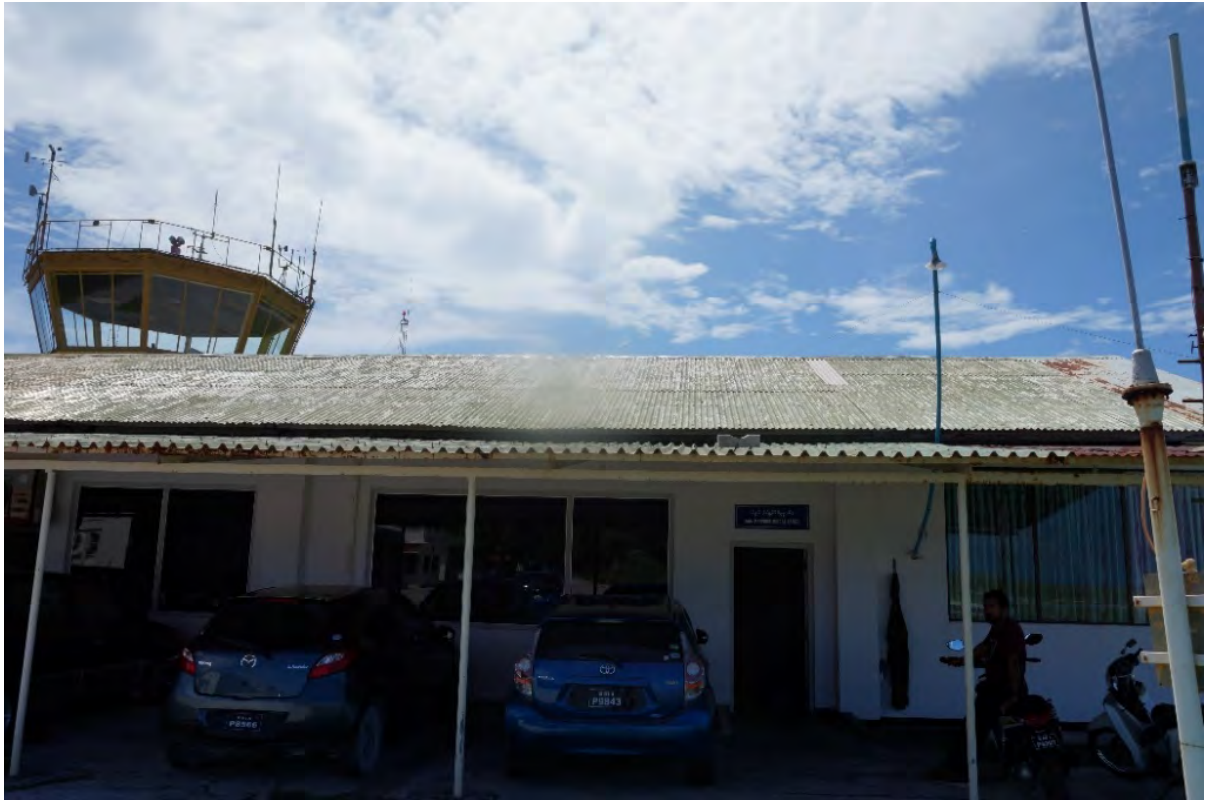
Figure 3: Office building

The office area includes three main office rooms, a small accommodation area and associated tea prep, ensuite, and locker area, as well as two adjacent buildings comprising a storage shed (permanently conditioned and including two work stations) and a hydrogen generation shed.

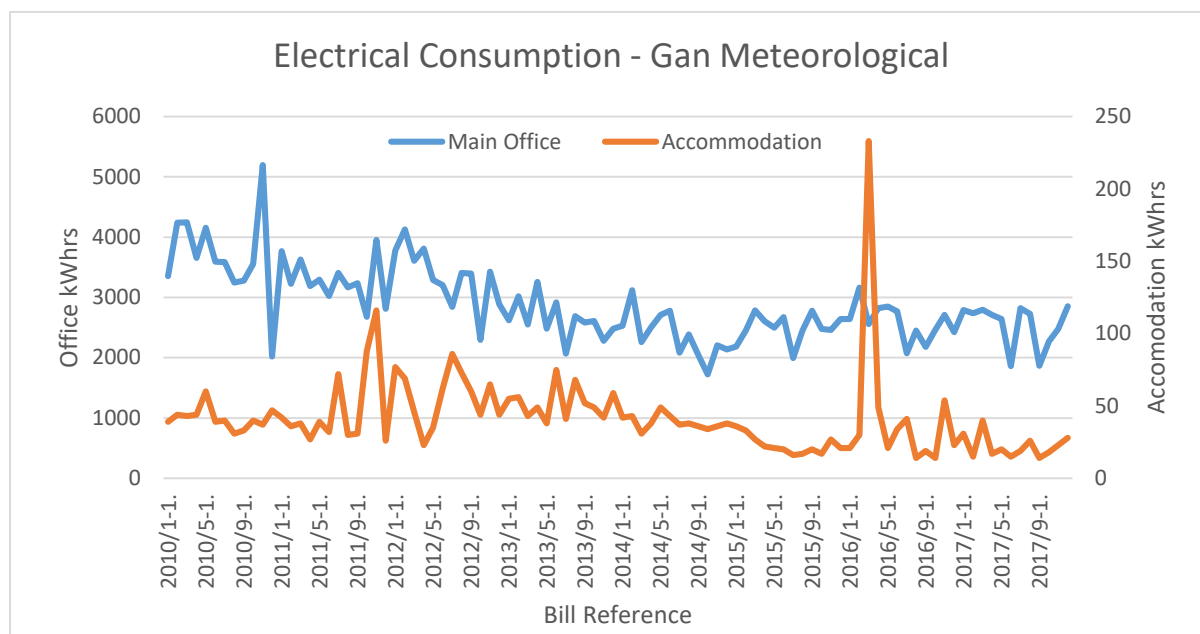
Figure 4: Energy consumption for each meter from January 2010 to December 2017 – as taken from electricity bills

Both meters show a consistent downward trend in monthly usage over the period. It is not clear what has driven the reduction in the office consumption, however, the accommodation block has seen reduced occupancy in recent times as occupants have increasingly used the area in the office block. In addition, increased occupant awareness of energy consumption and government initiatives to improve energy efficiency are expected to have contributed.

The reason for the unusually high consumption in May 2016 is unknown, however, based on the connected systems, the Team expect it is due to air conditioning and lighting being left on for the majority of the month.

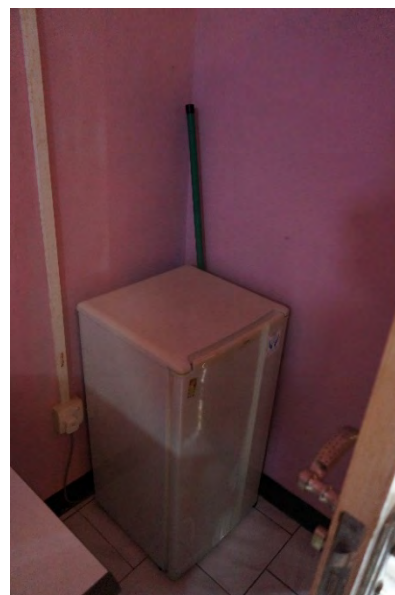
Figure 5: Refrigerator for the accommodation unit

Consideration should be given to decommissioning the fridge within the accommodation unit as this represents almost 100% of the power draw for the building and is not currently in use.

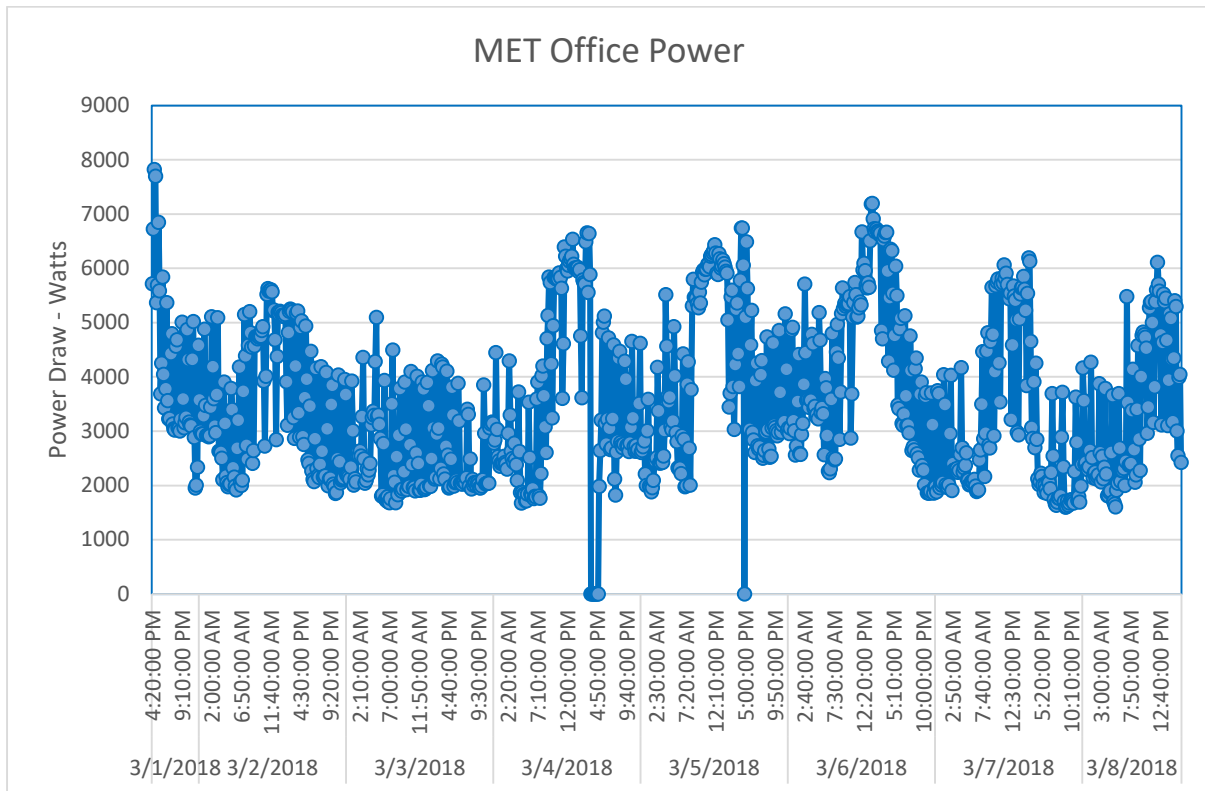
The data for the office shows a highly variable load of around 2kW which operates on/off with a period of around 10 minutes.

Figure 6: Energy logs for the MET office buildings

A review of the equipment on site indicated that the most likely cause of the $\approx 2\text{kW}$ jumps is the wall mounted air conditioning unit to the storage shed. This unit is not provided with an inverter and is required to operate 24 hours a day.

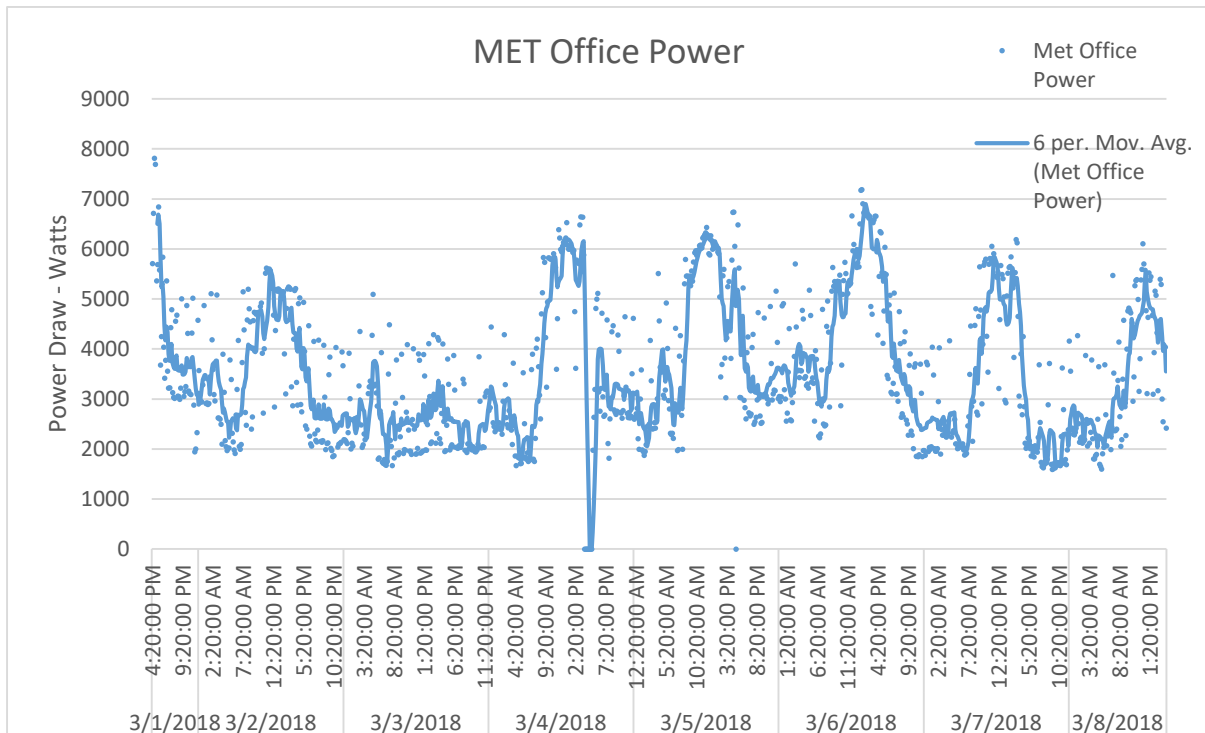
Figure 9: Average energy consumption per hour

Peaks in usage are evident for the weekdays and Friday, with Saturday being a period of marked low consumption. The base load is consistent overnight and reflective of minor quantities of air conditioning units and equipment running overnight – as would be expected for a building which operates 24/7.

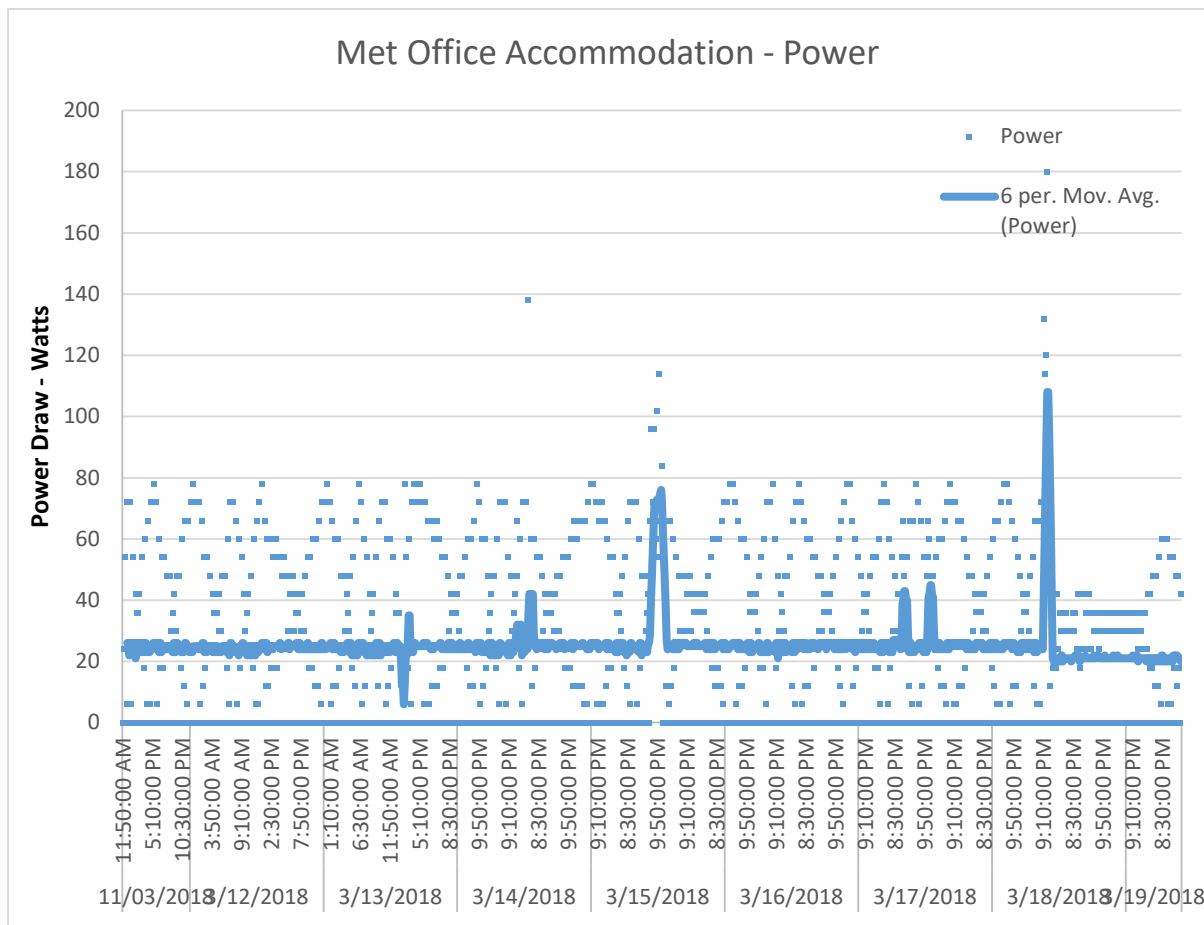
Figure 10: Energy logs for the MET office accommodation unit

The power consumption in the MET Accommodation unit is categorised by rapidly fluctuating power draws over 10-minute periods, hence, the graph above shows the actual data points as dots, with the hourly trend line plotted in solid colour. The data indicates that the building has an average draw of around 25W – which fell to around 20W from the 19th of March, which is most likely representative of the refrigerator turning on and off.

The plot shows brief periods (around 1 hour) of operation on the 15th and 18th, with other, shorter periods of operation on the 13th, 14th and 17th.

The most likely cause for these spikes is the operation of the air conditioning unit.

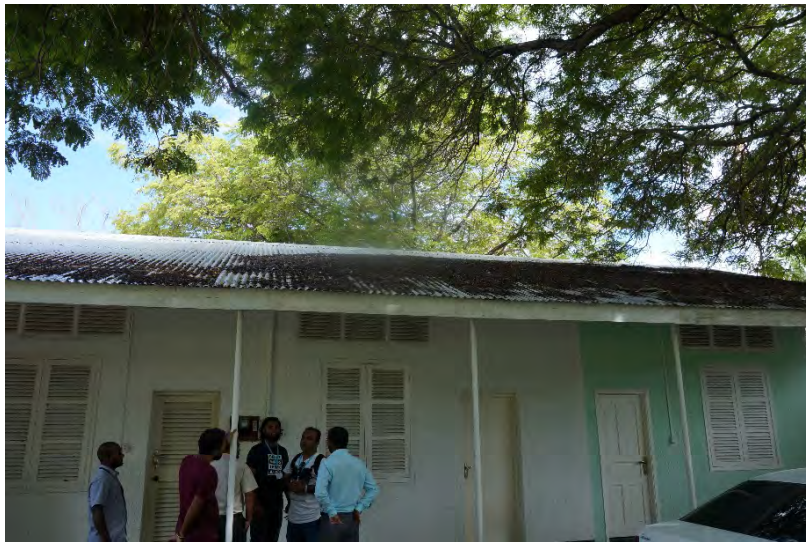
Both the office and accommodation facilities were constructed using the same method – masonry walls and metal roof. The roof for the accommodation is grey and is generally well shaded by an adjacent tree, whilst the roof for the office is a pale green. Modification of roof colour for the office to a lighter colour would reduce heat gain.

Figure 13: Roof of MET office accommodation unit

The image above shows the accommodation block as having a largely shaded, white or grey roof. The image below shows the exposed, light green roof of the office.

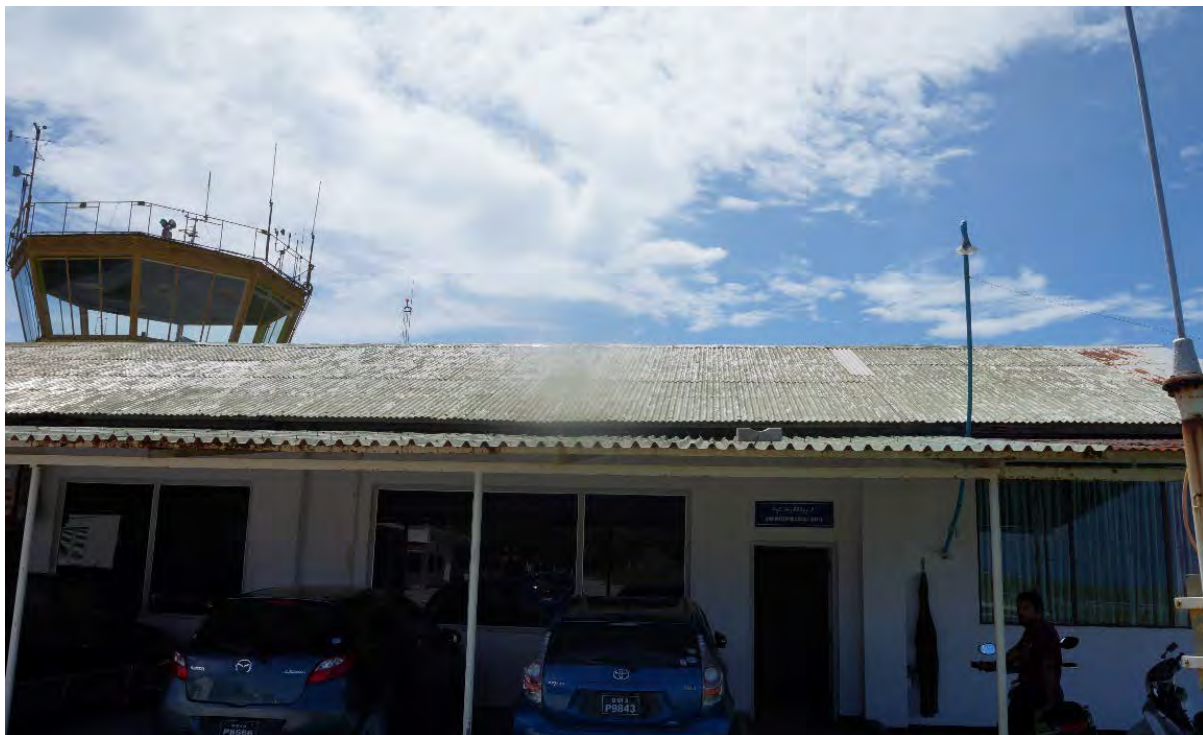
Figure 15: Roof of MET office building

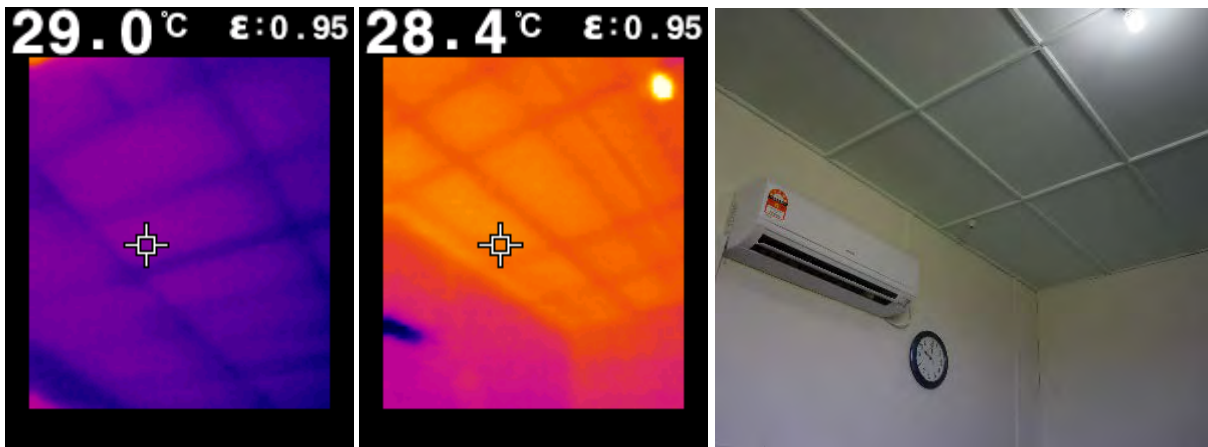
Figure 16: Thermal image of the ceiling of MET office building

Thermal image above shows timber ceiling elements as cooler than the general roof. This indicates the timber is providing more insulation than the adjacent void above the ceiling.

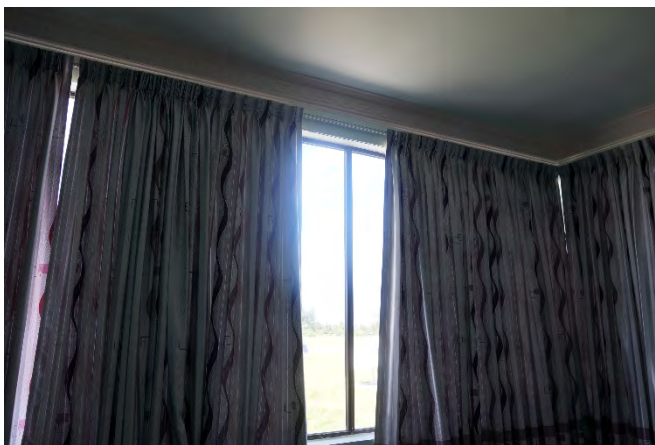
Figure 17: Glazing in the managers' office of Gan MET office

Glazing for the office building was well shaded on the long axis, however, glazing to the managers' office was unshaded and faced south – this is likely to result in heavy glare and heat gain issues for much of the year.

Glazing to the managers' office is shown left.

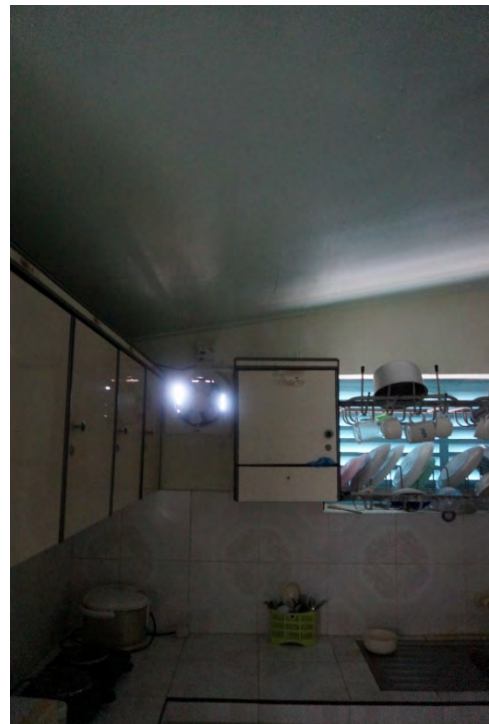
The image on the right shows the kitchenette, with the exhaust fan not sealed and louvres for ventilation over the windows. The room is not directly air conditioned, however is open to the rest of the building which is conditioned and is considered a significant energy leakage path.

These holes in the building envelope prevent effective sealing of the space.

Figure 18: Image to the right shows the kitchenette

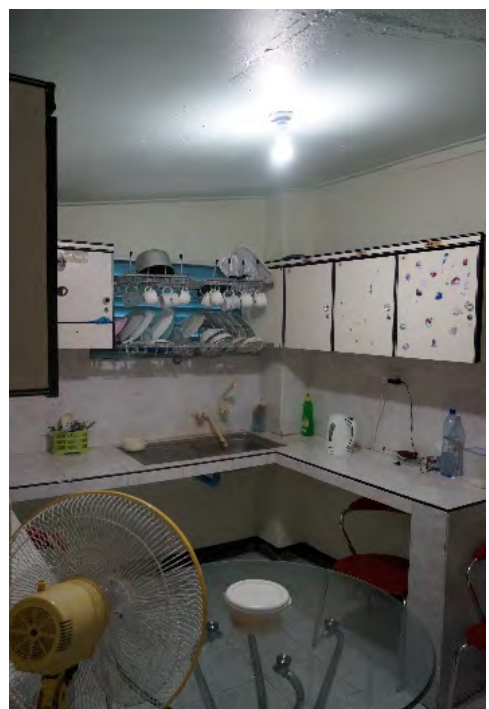
- Single Tube T8 – 1500mm long – (~45W)
- Single Tube T8 – 1200mm long – (~36W)
- Compact fluorescent light – (~20W) – right

There were no LED lights obvious during the inspection.

Figure 19: Image to the right shows Internal lighting for kitchen area

Lighting design power density is considered relatively poor and could be improved with replacement of compact fluorescent bulbs with similar luminance LED’s. Consideration should be given to replacing the tube lighting with LED’s.

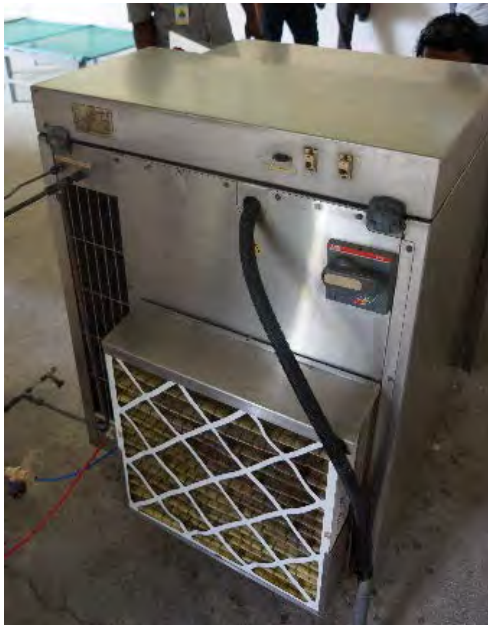
The site includes a hydrogen generator which consumes up to 45A (when in operation). The unit was operated at around 3pm on the last day of logging which indicated ~1kW power draw. The unit is shown left.

Figure 20: Image left shows the Hydrogen generator

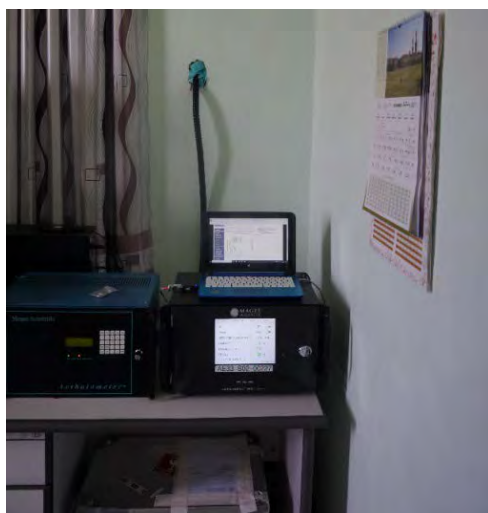
The managers' office also included an air monitoring station, which include a PC and is operational 24 hours a day, shown below.

Figure 21: Image left shows 24/7 air monitoring station at Gan MET Office

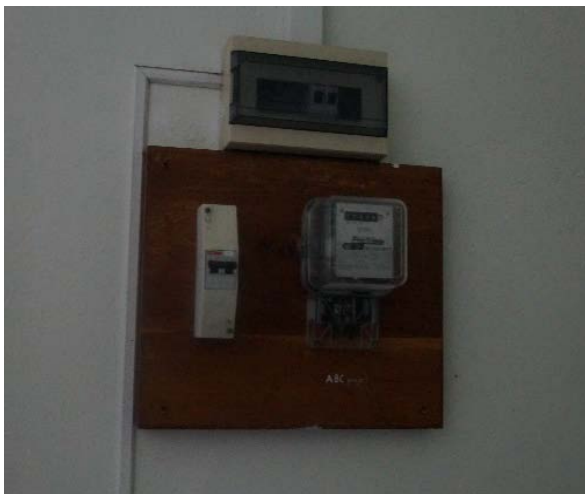
The office building is provided with a three-phase power supply to a relatively old meter and switchboard (left). The accommodation unit is provided with single phase power through a similarly aged board and metered arrangement (right).

Figure 22: Existing single-phase power board at MET Office Accommodation Block

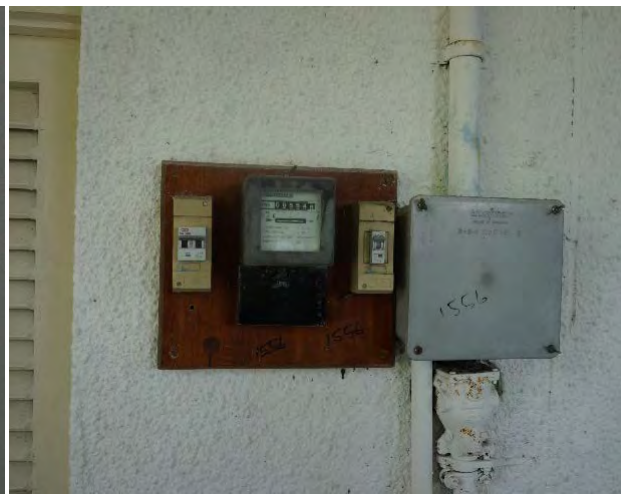
Figure 23: Existing three phase power board at MET Office

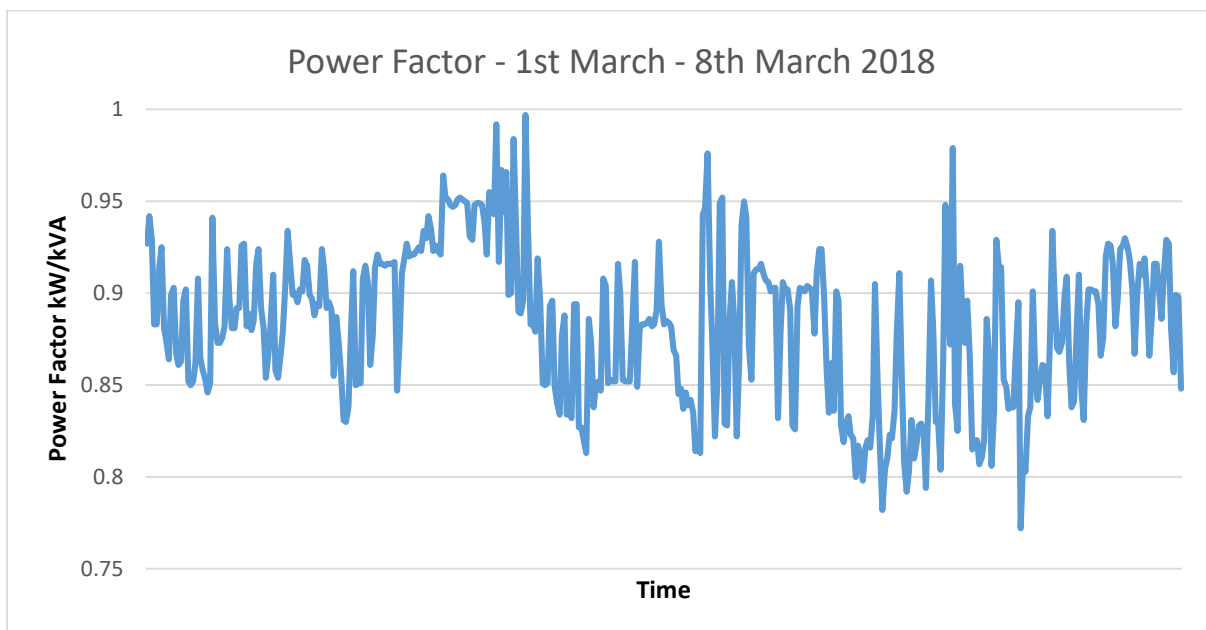
Figure 24: Power Factor for Gan MET Office block

The plot above shows the power factor over a one week period for the office building. The overall average for the period is around 0.88, which is considered fair, however, there are some periods with power factor as low as 0.77.

- Power Factor Correction
 - Power factor correction is not considered applicable for this site. The accommodation utilises single phase power only and the quanta of energy consumed by the office is not likely to contribute to an economically advantageous installation of power factor correction for the office.

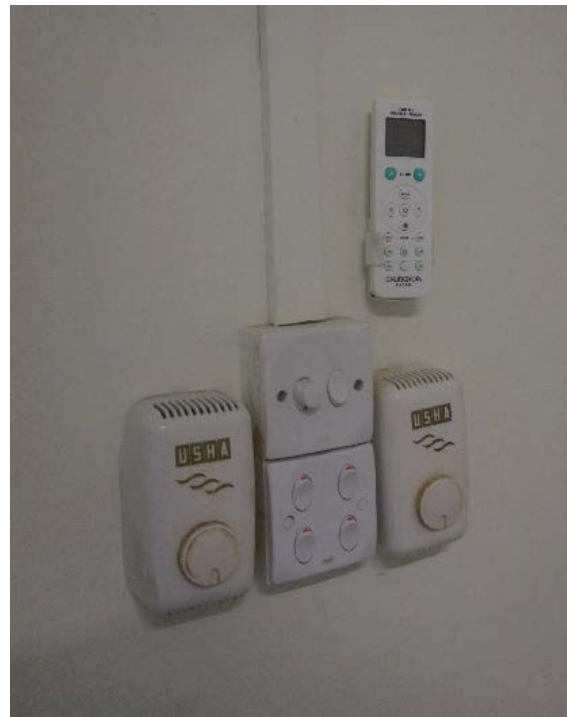
Building controls are manual for air conditioning, lights and ceiling fans – as shown right.

Air conditioning remotes are used for temperature control and, in some instances are mounted in areas which are influenced by air movement from the unit directly, providing a false reading on temperature within the space.

Figure 25: Figure above shows the fan, air conditioning and lighting controls for the office building

Sensors should be located in the air body, but outside of the air stream controlled by the air conditioning unit.
