Environmental and Social Monitoring Report

Establishment of Island Waste Resource Management Centre – Gan, Laamu Atoll

Prepared for: Ministry of Tourism and Environment

December 2025

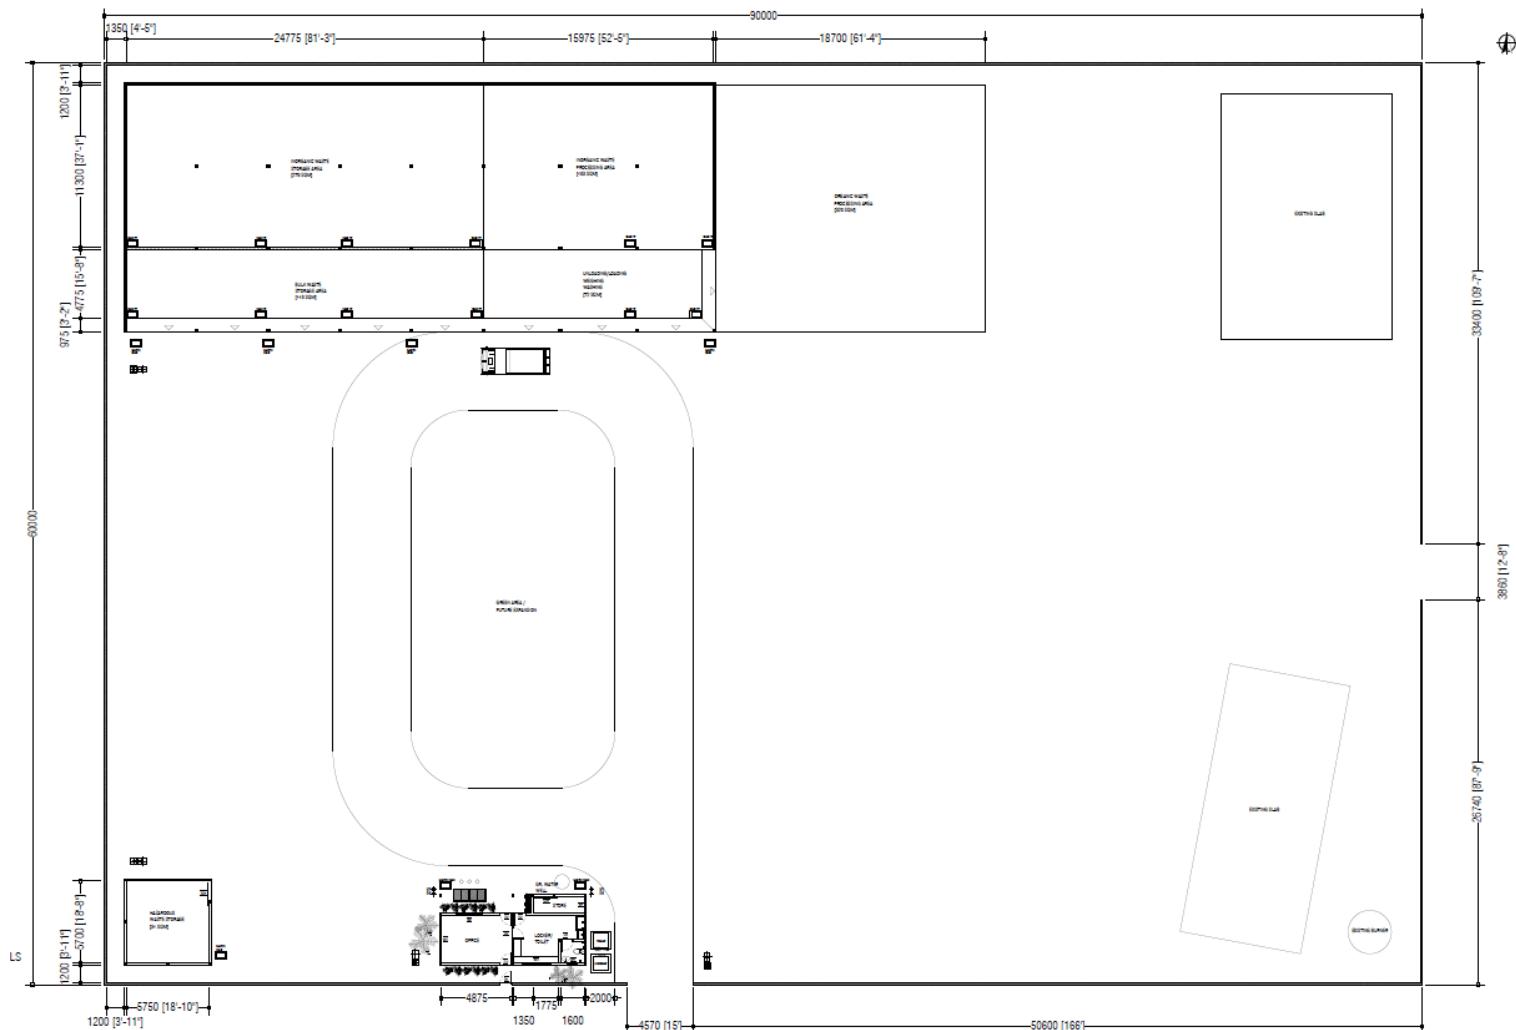
Figure 1 Gan WRMC Layout

- **Waste unloading, loading and weighing area**
 - A roofed area of 72m² with concrete slab designated for weighing and sorting of incoming waste to organic and inorganic fractions.

- **Inorganic waste processing area**
 - A roofed area with concrete slab where waste will be further segregated into plastic, metal, glass etc. and processed via baling, compaction and crushing. This processing area has an approximate area of 183m².

- **Processed inorganic waste storage area**
 - A roofed area with concrete slab where the processed inorganic waste will be stored. The storage area has an area of 279m². The design considers storage of such waste for 4 – 6 months, which will then have to be transferred to the Regional Waste Management Facility (RWMF).

- **Bulk waste storage area**
 - A roofed area of approximately 118m², with concrete slab, designated for the storage of bulk waste such as old furniture, roofing sheets etc.

- **Hazardous waste storage area**
 - A fully enclosed room of 31m² area, with a roof, concrete slab, 4 walls and a gate, where the received hazardous waste will be stored prior to its final disposal at a RWMF. Appropriate hazard, flammable liquid and warning signage will be installed.

- **Organic waste composting area**
 - A 320 m² fully enclosed, roofed area with a concrete slab and brick walls is proposed in the design to expand operations for in-vessel composting. This is planned as a future development and is not included under the current civil works contract.

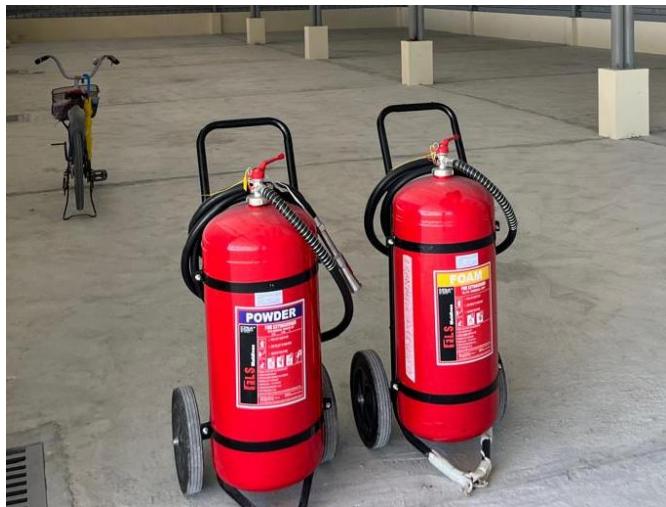
Figure 2 Fire Extinguishers at the facility

- **Fire safety equipment**
 - Fire safety equipment was supplied and installed as part of the contract, which essentially includes:
 - 50KG DCP Trolley 2 nos.

- 50LTR Foam Trolley 1 no.
 - Wet Chemical 6Ltr with Cabinet for hazardous waste area 1 no.
 - Water 9Ltr with Cabinet for Office Area – Outside 1 no.
 - CO2 2KG with Cabinet for Office Area – Outside 1 no.

Item no:	Equipment	Quantity	Location
1	50KG DCP Trolley	2	Collection bay
2	50 Ltr Foam Trolley	1	Collection bay
3	Wet Chemical 6 Ltr with Cabinet	1	Hazardous Waste Area
4	Water 9 Ltr with Cabinet	1	Outside office
5	CO2 kg with Cabinet	1	Outside office

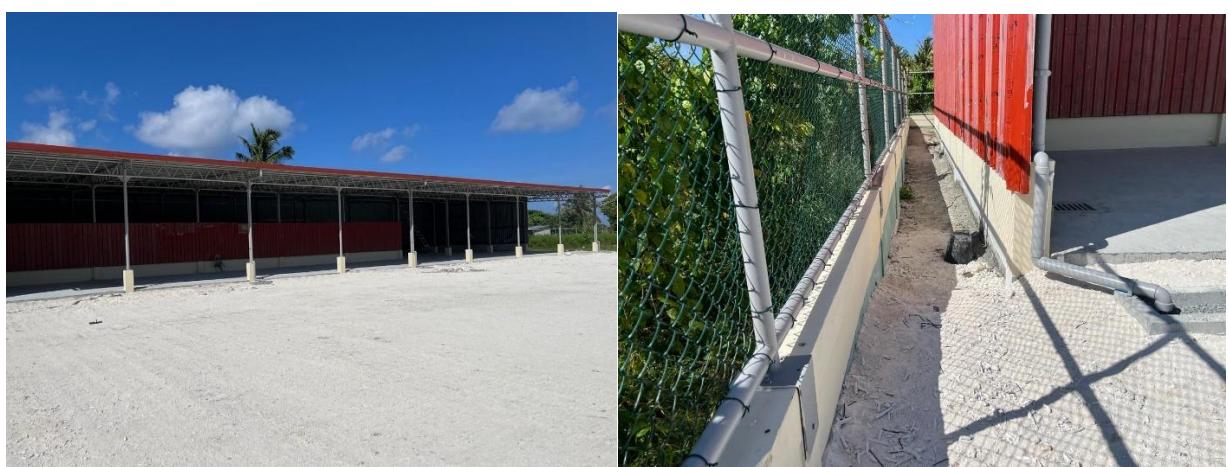
Figure 3 Photos of Gan WRMC

All the major construction works of the project were completed on 09th November 2025, including plumbing, electrical works and fixing of fire safety equipment.

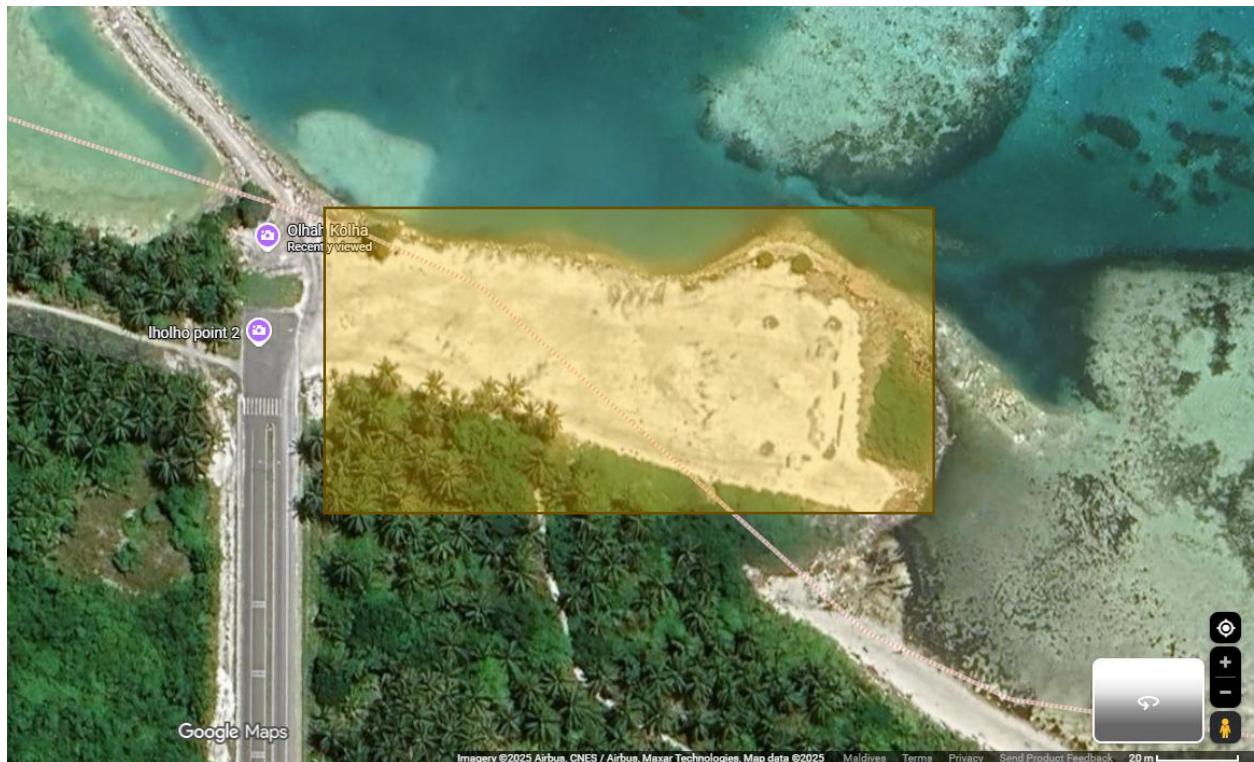
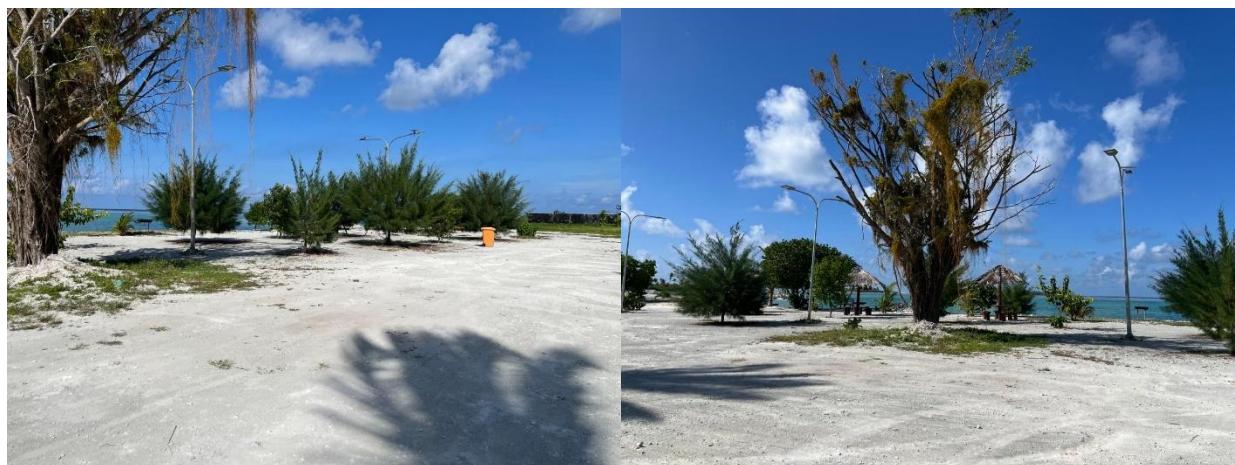
Figure 5 Replantation location and photos

2:1 replantation was carried out by the island council at the northern tip of the island, east to the main road (causeway). A total of 40 trees were planted as per the information provided by the council, which was verified by the PMU during the 13th November 2025 site visit.

Details of Vegetation/ Replantation /Translocated	Quantity
Juvenile medium Coconut palm	17
Immature breadfruit	2
Number of trees translocated	0
Number of trees Removed/ Chopped	19
Number of trees Replanted	40

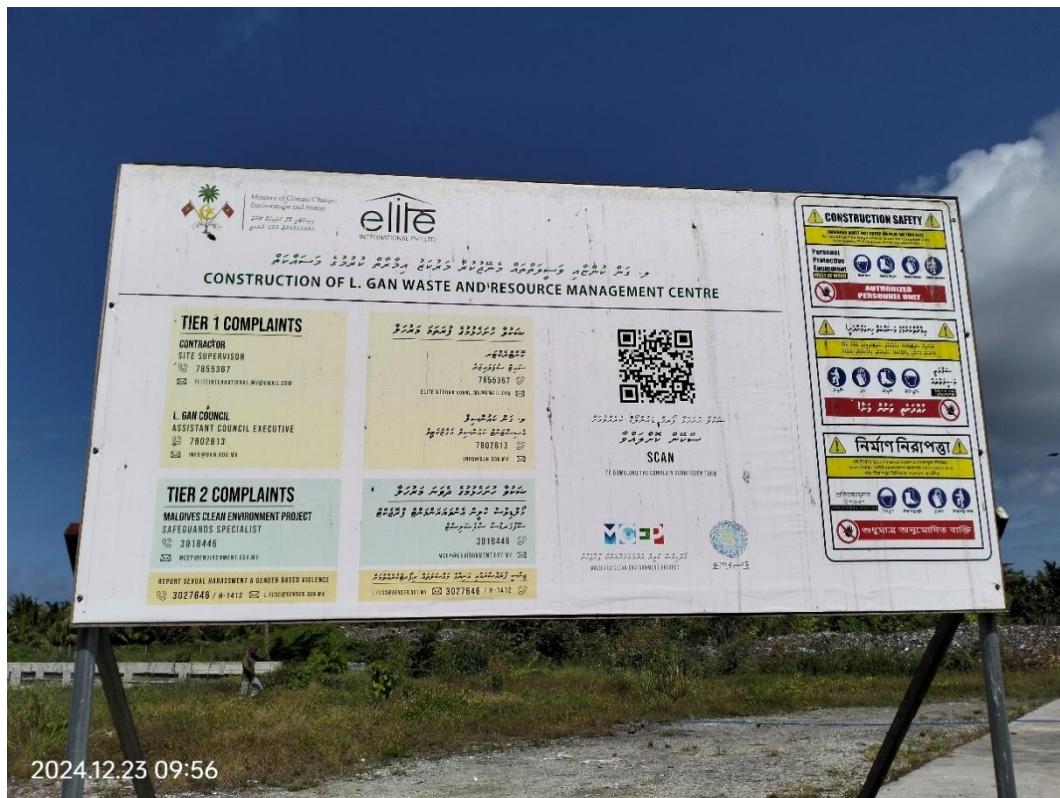
Figure 6 GRM board displayed at project site

The Grievance Redress Mechanism (GRM) of MCEP was fully functional at L. Gan. The Council appointed one of its employees as the waste management focal point responsible for managing Tier 1 grievances. Any grievances that could not be resolved at the Island Council level were to be referred to the PMU (Tier 2). Contact details and a QR code for accessing the online complaint form were displayed at the project site and in community Viber group maintained by the Council.

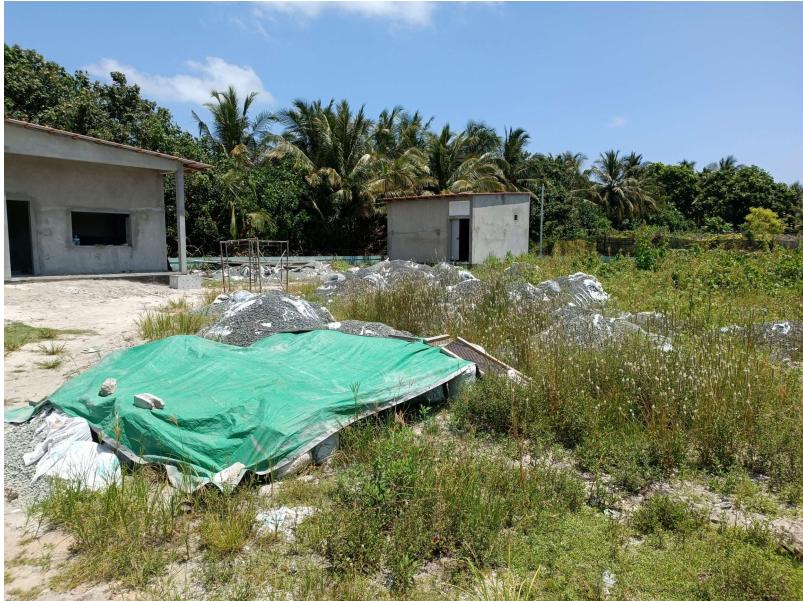
IMG_20250422_124227-12_48_29.jpg

ATTACH PHOTO OF THE SITE TO INDICATE GROUND CONDITION

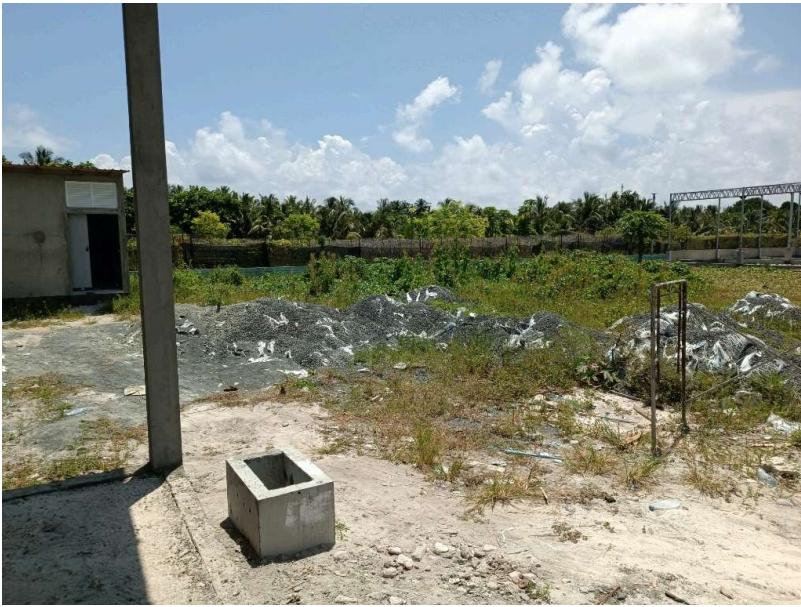
17453081371209054006460642386274-12_49_3.jpg

ARE STOCKPILED CONSTRUCTION MATERIALS COVERED?

Yes

ATTACH PHOTO OF HOW MATERIALS ARE STOCKPILED

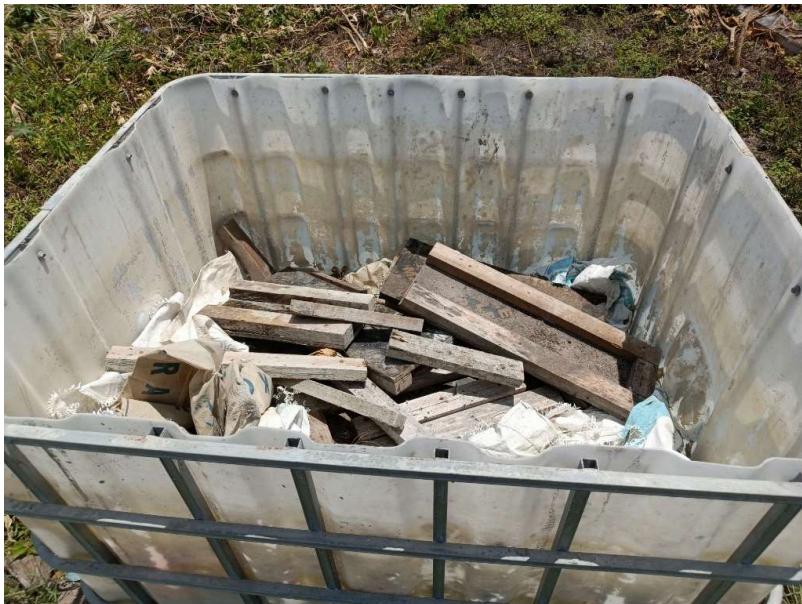
1745308840923482771573393357370-13_1_5.jpg

IS CONSTRUCTION AND DEMOLITION WASTE (C&D) AND/OR GREEN WASTE GENERATED FROM THE PROJECT?

ATTACH PHOTOGRAPHIC EVIDENCE

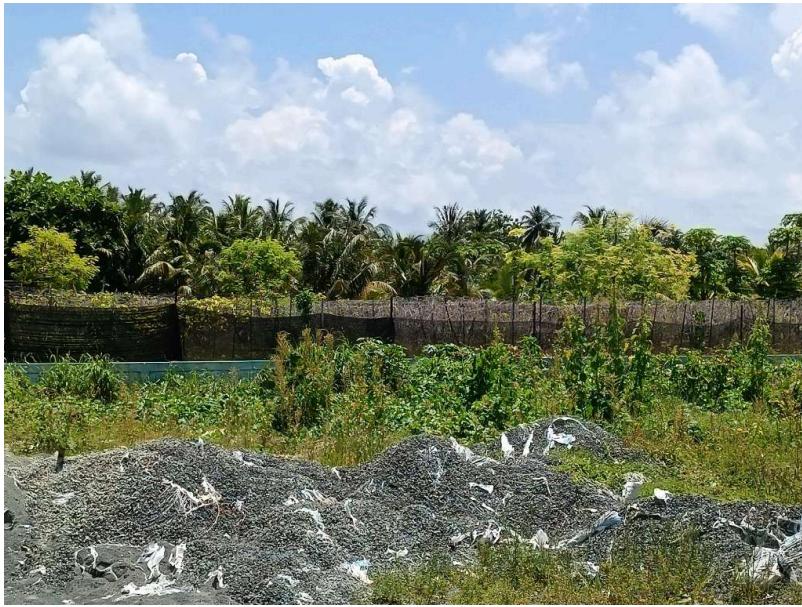
17453081811354571146462446815701-12_49_46.jpg

ATTACH A PHOTOGRAPH OF SITE DEMARCTION

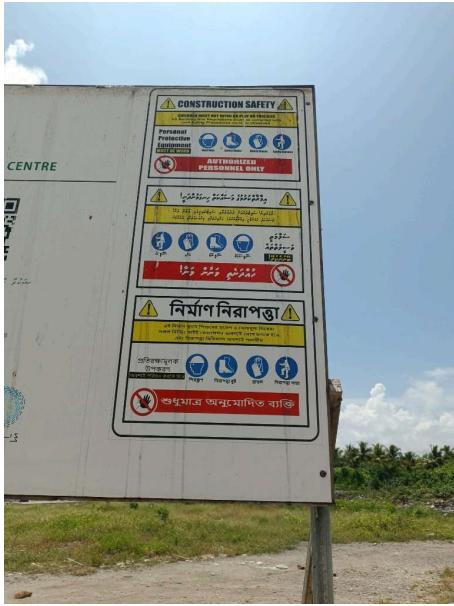
17453089113817476437777657454174-13_2_1.jpg

IS NO ENTRY SIGN BOARD PRESENT?

ATTACH A PHOTOGRAPH OF NO ENTRY SIGN BOARD

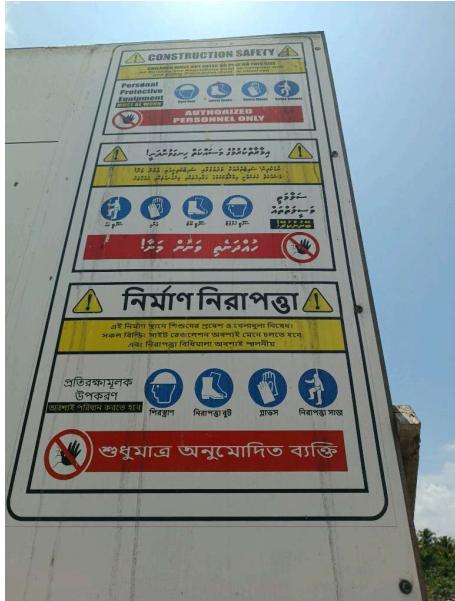
17453089441346585204863940399922-13_2_30.jpg

IS SAFETY SIGN BOARD WITH PPE REQUIREMENT PRESENT?

Yes

ATTACH A PHOTOGRAPH OF PPE SIGN BOARD

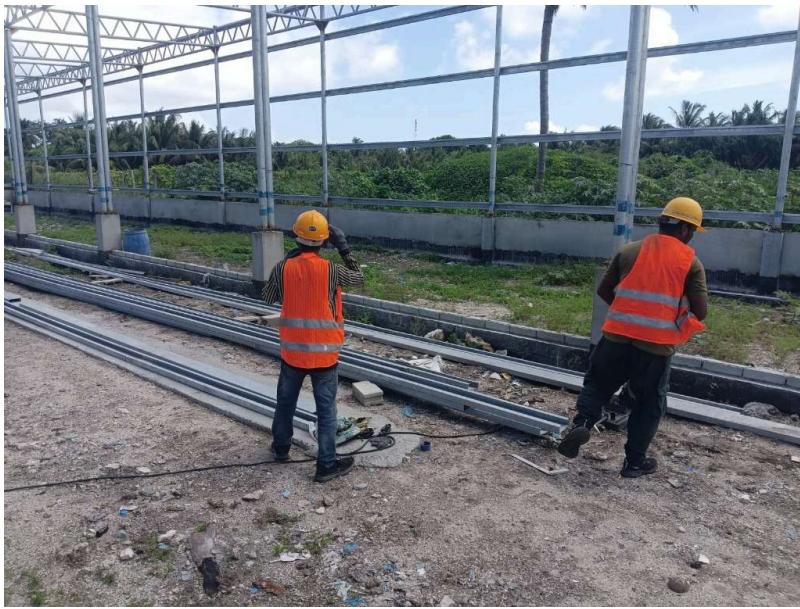
L. Gan-11_36_40.jpg

ATTACH A PHOTOGRAPH OF WORKERS WITH BOOTS/COVERED SHOES

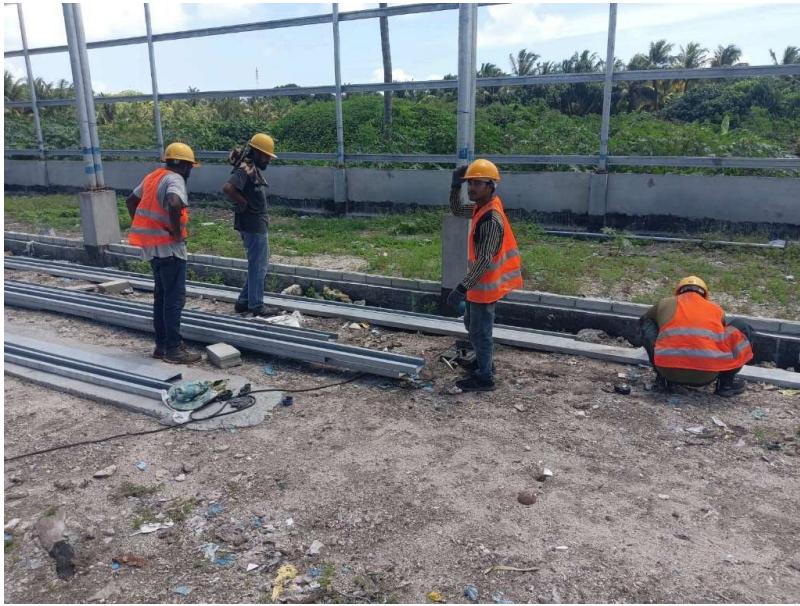
L. Gan Photo_15-05-2025-11_36_47.jpg

ATTACH A PHOTOGRAPH OF WORKERS WITH HARD HATS

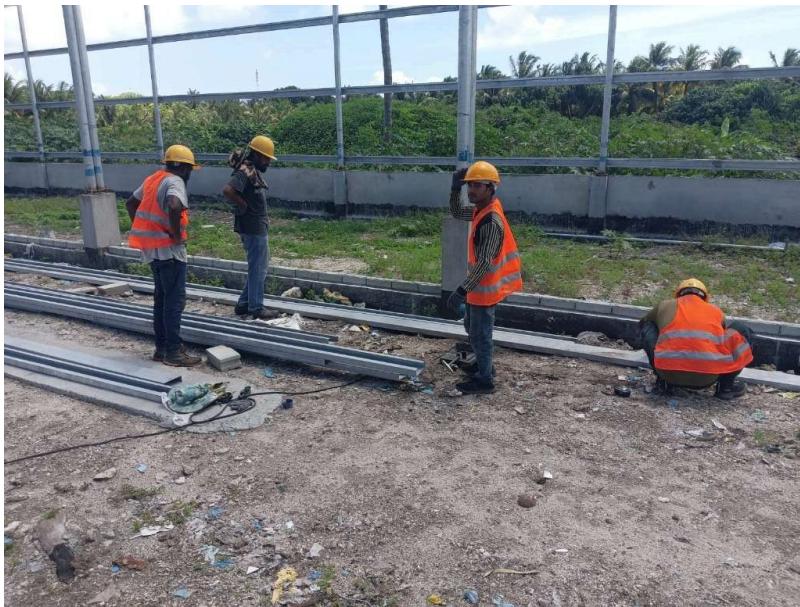
L. Gan Photo_15-05-2025-11_36_51.jpg

ATTACH A PHOTOGRAPH OF WORKERS USING LUMINOUS JACKETS

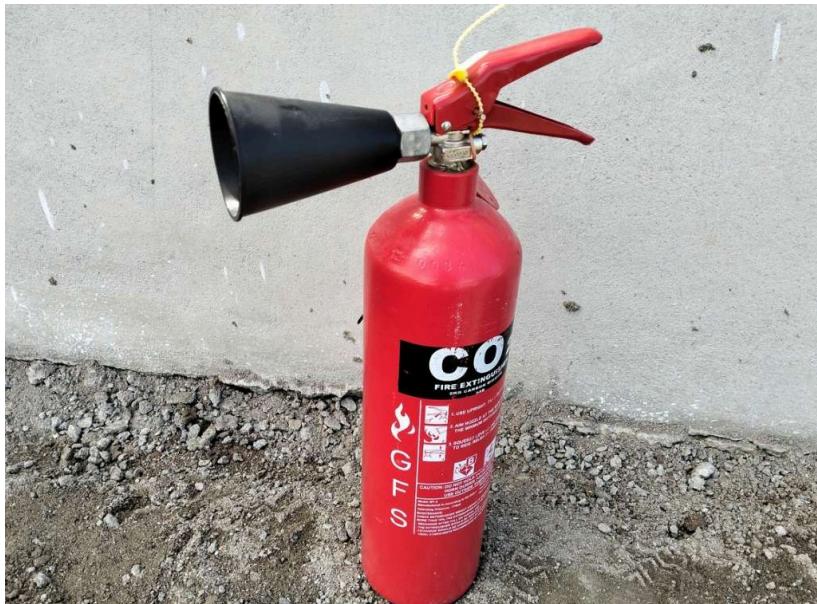
F.E-19_10_48.jpg

ATTACH PHOTOGRAPHIC OF EXTINGUISHER

No open electrical wires are found
 Electrical wires installed by certified person

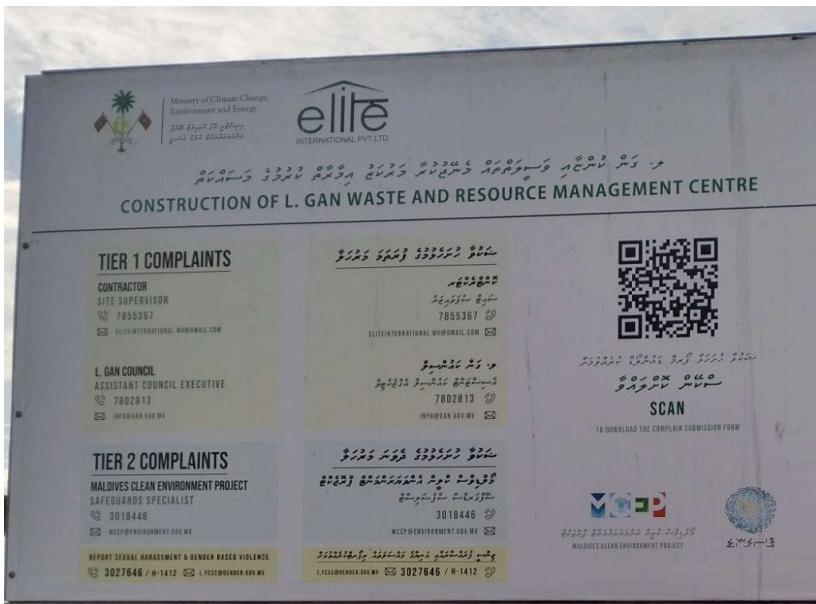
March Pc_02-19_4_15.jpg

ATTACH PHOTOGRAPH OF THE GRM BOARD
