I certify that the statements made in this Environmental and Social Monitoring Report for the Upgrading of Infrastructure at R. Vandhoo RWMF, are true, accurate and complete to the best of my knowledge.

#### UPGRADING OF DISTRIBUTION NETWORK AND FUEL STORAGE CAPACITY AT NORTHERN RWMF

## SUPPLY, INSTALLATION AND COMMISSIONING OF RO PLANT WITH BOREHOLE | R.VANDHOO RWMF

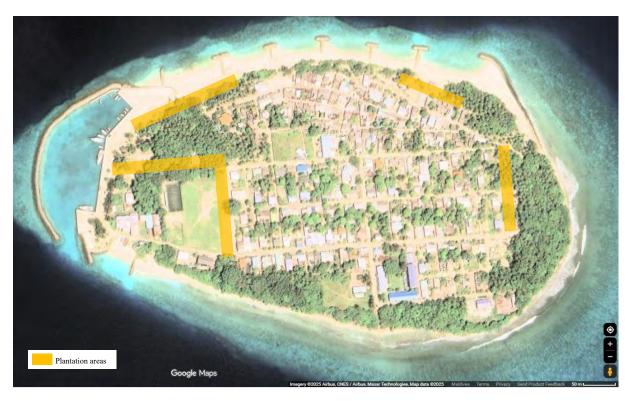
Figure 2 R. Rasmaadhoo Plantation Areas

In Innamaadhoo, replantation was conducted around the futsal ground, within the school compound, and behind the powerhouse. In Rasmaadhoo, it was carried out along the roadside and in the harbour area. A total of 225 trees were planted. **Figures 2** and **3** depict the replantation areas. Photos of replantation process are provided in **Annex 6**.

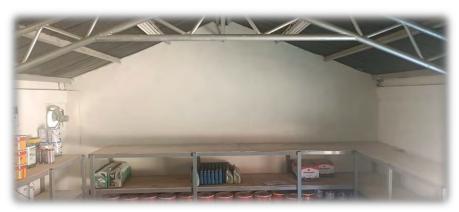
Figure 6 Audit report recommended actions conducted

- Extinguishers and signboards at the existing fuel storage meet the requirements for a temporary setup.
- The chemical store requires some modifications to comply with chemical regulations. Tube lights should be enclosed in covers, and the wooden partition separating the chemical store from the timber store should be replaced with a brick wall.

- The CO<sub>2</sub> and DCP extinguishers inside the timber store should be moved outside for better accessibility.
- The warehouse (store) was found to have no issues.

- No issues were observed in the sorting, baling, and waste storage bunkers.
- At the incinerator building, existing extinguishers and signage provide adequate coverage, but additional DCP and CO<sub>2</sub> extinguishers are recommended near the day tank.

- Mobile pumps were tested and found to be functioning properly. Their location is effective, providing access to the most fire-critical areas (fuel storage and incinerator).
- The dry powder extinguisher at the kitchen should be replaced with a wet chemical extinguisher.
- The manual alarm system was tested and confirmed to be working well, with good coverage.
- Fire wardens at the facility are trained to respond to incidents. However, a minimum of four fire suits should be procured for firefighting personnel. The report also recommends forming a fire squad at the facility, equipped with the necessary certification.
- The audit team emphasized the need to install a fire hydrant system.

Following the audit, a timeline for completing the recommended remedial actions was developed and shared with WAMCO. All necessary actions were completed by March 2024. The full audit report and details of remediations activities completed are provided in **Annex 8**.

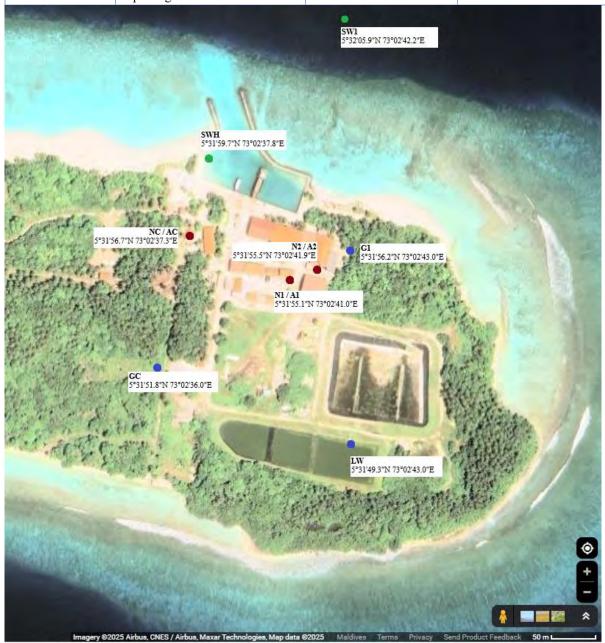
Figure 8 Sampling Locations

Sampling Location	Geographic Coordinates	
G1 (Fuel Farm)	5°31'56.2"N 73°02'43.0"E	
GC (Control – sampling well)	5°31'51.8"N 73°02'36.0"E	
SWH (Harbour Basin)	5°31'59.7"N 73°02'37.8"E	
SW1	5°32'05.9"N 73°02'42.2"E	
LW (Leachate Pond)	5°31'49.3"N 73°02'43.0"E	
N1, A1 (Powerhouse)	5°31'55.1"N 73°02'41.0"E	
N2, A2 (Incinerator)	5°31'55.5"N 73°02'41.9"E	
NC, AC (Control – Mosque)	5°31'56.7"N 73°02'37.3"E

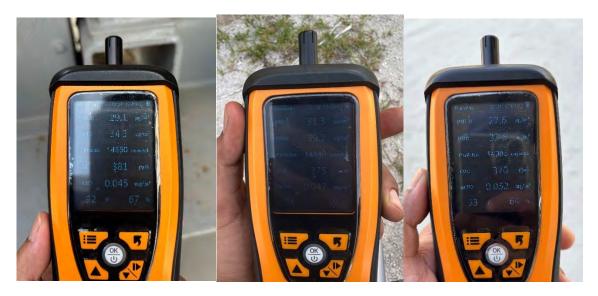
Figure 9 Incinerator/WtE, Powerhouse, Control (left to right)

The ambient air quality observed across Vandhoo is relatively consistent, with no significant differences between the incinerator/WtE, the powerhouse, and the control location. Both PM2.5 and PM10 levels are highest near the powerhouse, followed by the incinerator/WtE and then the control site, though the differences are only marginal.

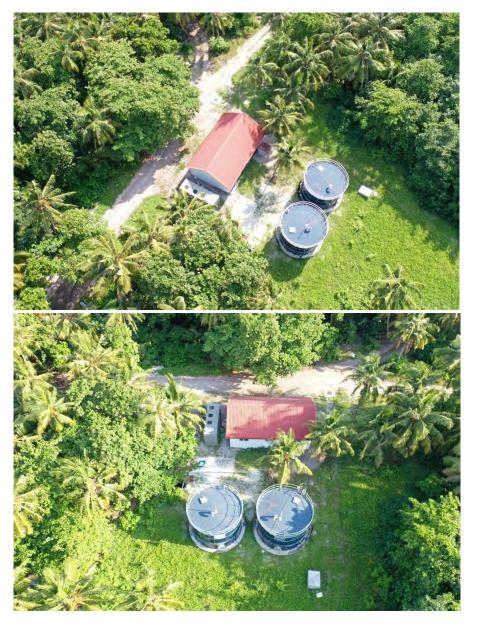
Figure 10 RO plant

The details of vegetation clearance for the sub-project implementation are covered comprehensively in Chapter 4. During the site visit, drone assessments were conducted to further evaluate the extent of vegetation removal across the project sites, including the RO plant and the Fuel Farm. These assessments confirmed that vegetation was cleared only within the designated project sites, while the vegetation at the periphery and surrounding areas remained intact.

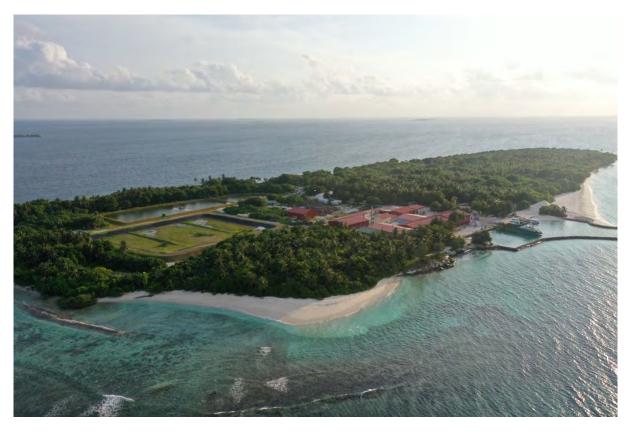
Figure 12 Vegetation buffer

Furthermore, the assessment reveals that the vegetation buffer surrounding the island has been maintained in accordance with ESIA requirements, except for the harbour and slipway areas. (Note: The slipway project does not qualify as an associated facility under the Environmental and Social Framework (ESF) and is covered under a separate Environmental Impact Assessment (EIA) conducted by the developer to fulfil national requirements.)

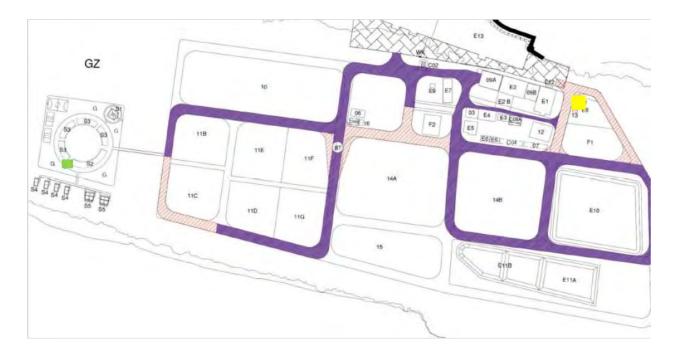
The fuel storage tanks are to be located on the northeastern side of the island, within the area initially developed in the 15ha (Figure 1). An area of approximately 150m<sup>2</sup> has been allocated for the purpose (dimensions of the plot are given in Figure 2, Annex 1 gives large scale drawings of the design).

Figure 1. Proposed location of fuel tanks (yellow highlight), septic tank (green highlight) and road connections (red hatch). The purple hatch shows roads proposed in earlier reports

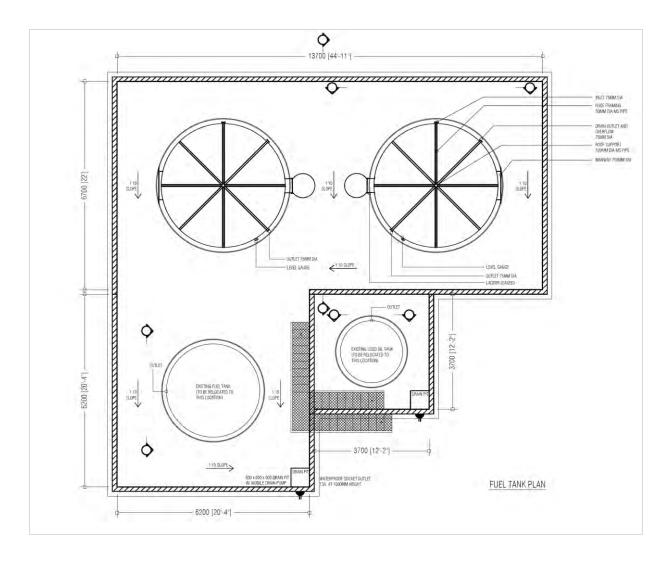
Figure 2. Fuel tank plan

It is proposed to construct 2 fuel tanks of 50m³ (4m x 4m height and width) each at the location. The existing 24m³ fuel storage tank that will be decommissioned after temporary fuel storage setup is established, will also be moved to the newly proposed storage area, hence having a total capacity of 124m³. The fuel storage tanks will be constructed with 8mm thick MS tank plate wall with 10mm thick MS plate tank base for placement on concrete foundation (200mm RC slab). The tanks have a flanged nozzle of diameter 75mm at the top as the inlet and at the bottom as the outlet. Refer to Figure 3 and the drawing in Annex 1 for the fuel tank design and location of inlet and outlet pipes of fuel transfer. The existing 8m³ used oil tank will also be decommissioned and moved to the fuel farm to be established.

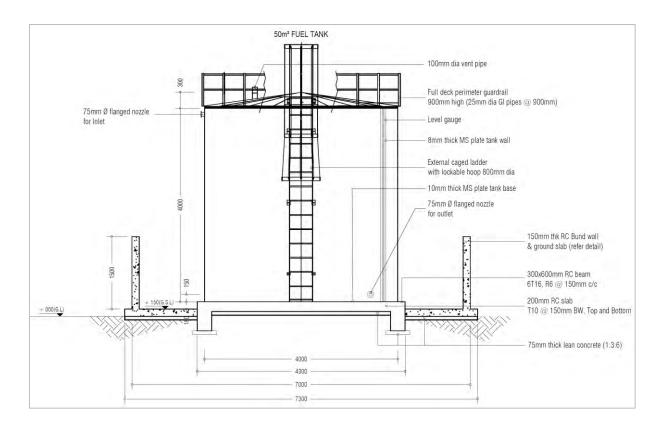
Figure 3. Fuel tank design

A 150mm thick bund wall and ground slab will first be constructed at the location proposed for fuel tank construction. The bund wall has a height of 1.5m. Once the bund wall is completed, the fuel tank (50m³ steel tanks) will be installed at the proposed location using a crane. Concrete bund wall is designed to encase any leak from the tanks; the volume encased by the bund walls will be able to hold the full volume of the storage tanks.

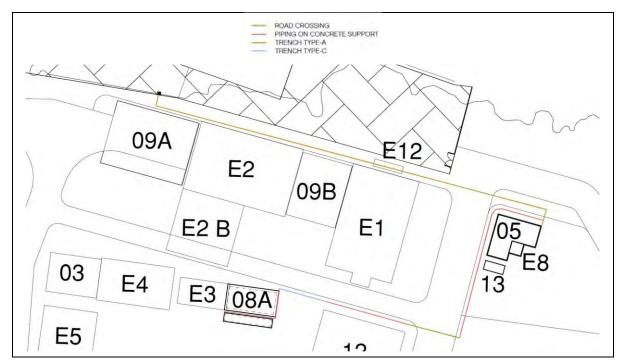
Pipes will be laid underground in trenches (Figure 4). The pipeline from the harbour front area to the fuel farm will be laid in Trench of depth 550mm and width 850mm. The trench has RC walls and a cover, all with a thickness of 150mm. All 4 pipelines (for diesel inlet / outlet and used oil inlet / outlet) will be laid alongside each other on a PVC pipe support slab (50 mm thick). The pipelines all have a diameter of 75mm and are 3mm thick.

Figure 4. Fuel pipeline from harbor to fuel storage tanks and from fuel storage tanks to powerhouse

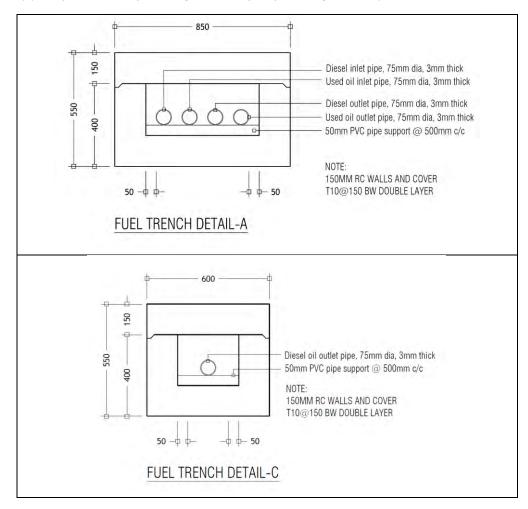
The pipeline from the fuel storage area to the powerhouse will be laid on concrete support, although a segment of it close to the powerhouse will be in a 550mm deep, 600m wide trench (type C). Designs of the fuel trenches are given in Figure 5 and Annex 1.

Figure 5. Trench layout diagrams (large scale diagrams given in Annex 1)

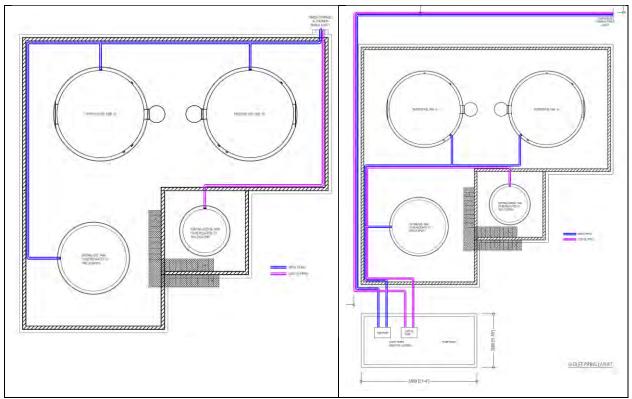
The pipeline plan inside the fuel storage area is shown in Figure 6 (larger diagram in Annex 1), which shows that the inlet pipeline for both diesel and used oil, connect to the respective storage tanks, with the diesel inlet pipeline having 3 separate connections to the three storage tanks. From the storage tanks, a pipeline runs to the respective pump within the facility. Pipeline going out from the pumps connect to the main pipeline and continue as shown in Trench layout diagrams.

Figure 6. Piping plan inside the fuel storage area (pink: used oil pipeline, blue: diesel pipeline) (Left: Inlet piping plan, right: outlet piping plan) (large scale drawings given in Annex 1)

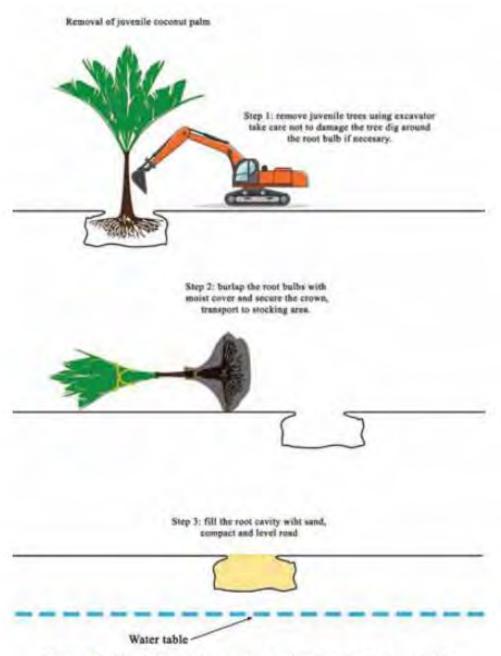
Once the palm tree is carefully extracted it will be transported and stacked at the harbour area, where it will be transported out of the island by concerned parties. The root ball cavity will be filled and levelled. Sand shall be used as a fill material for the root cavities before levelling. (See Figure 8 for an illustration of uprooting method)

Figure 8: Illustration of uprooting palm trees for re-plantation

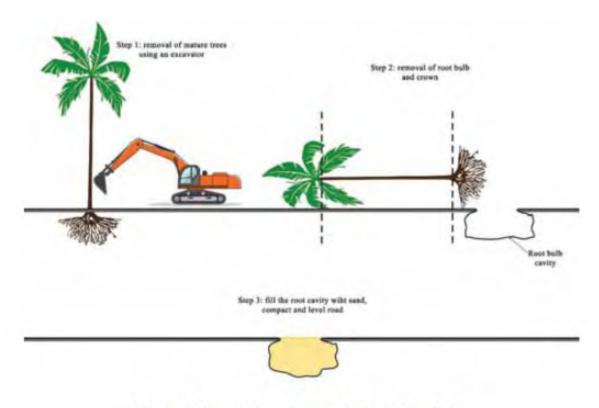
All fronds and root bulb and base of the trunk of the tree that is felled for timber or firewood shall be cut using a chainsaw and only trunk will be transported to the stockpiling area to be sold. Parts of the root bulb will be used for backfilling of the depression created (See Figure 9 for illustration of removal method). The use of root bulbs for backfilling or grinding the stump of the root bulb will minimise waste generated during site clearance, maintain original soil conditions as well as minimise additional sand needed for filling. All fronds and nuts will be removed from the terminal bulb and piled up separately. Nuts will be sold and fronds will be left to dry and eventually burned. All residual waste shall be disposed of as described in Section 2.3.16.

Figure 9: Illustration of removal of trees for timber

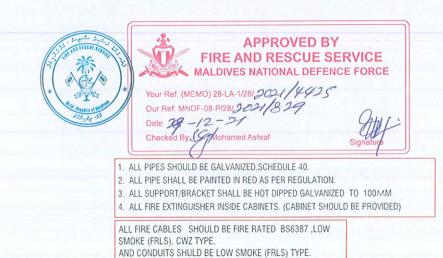
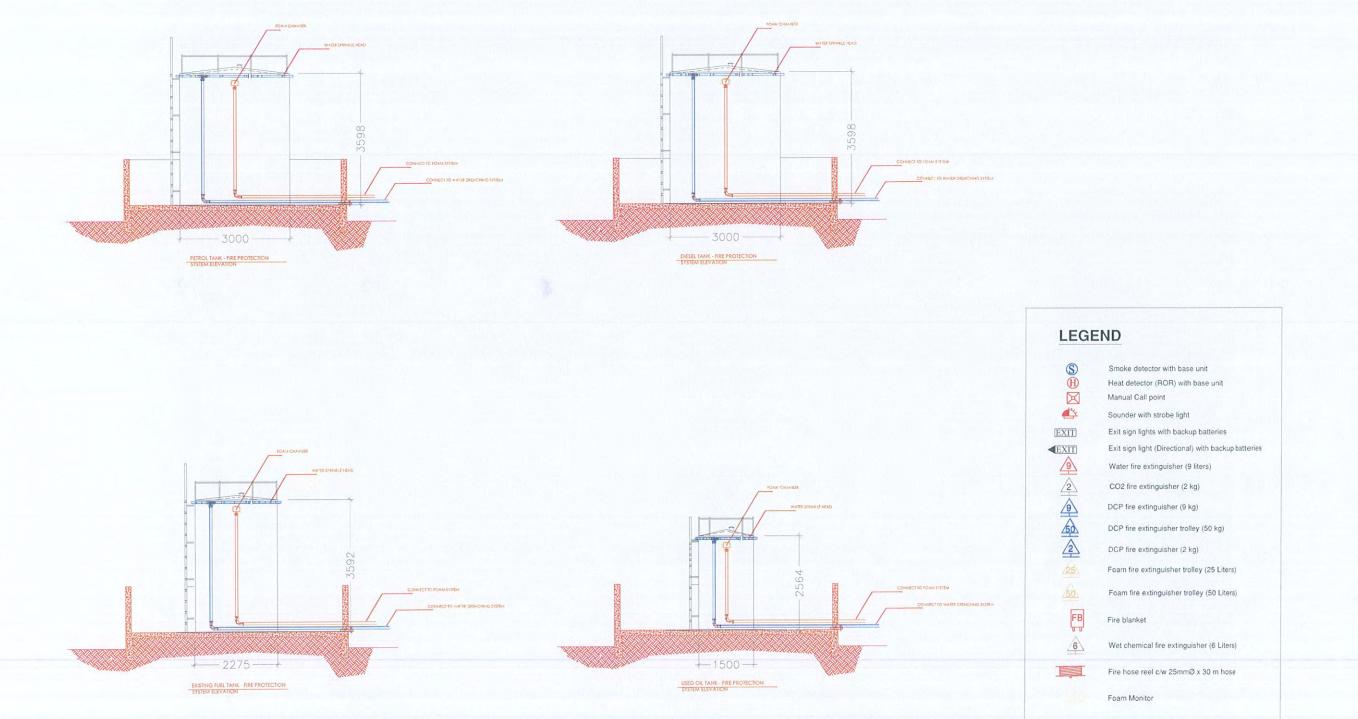
Title: Fuel Farm FP layout

## **FUEL FARM WATER DRENCHING SYSTEM LAYOUT**

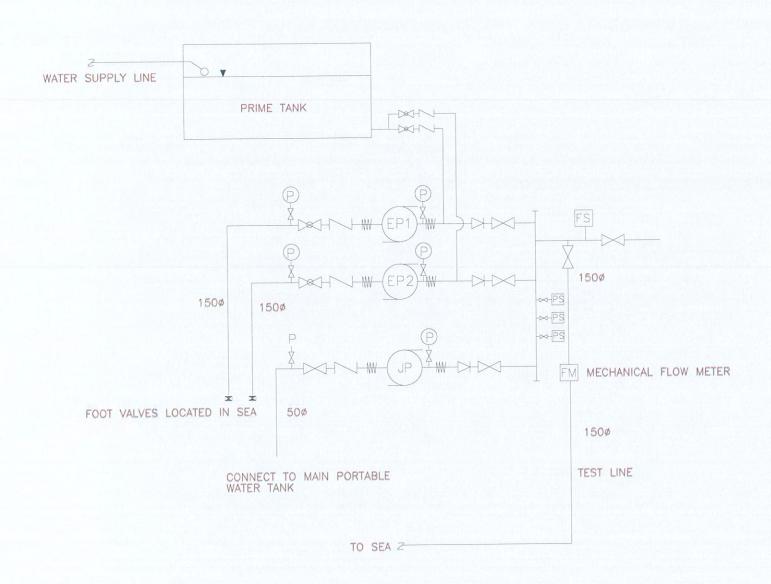
EP1- ELECTRICAL PUMP 500Lpm @85m EP2- ENGINE PUMP 500 Lpm @85m

JP - JOKY PUMP 10 Lpm
