# **Report to the Ministry of Environment, Republic of Maldives**

## **Preliminary site survey of Kulhudhuffushi mangroves**

**18 May, 2019**

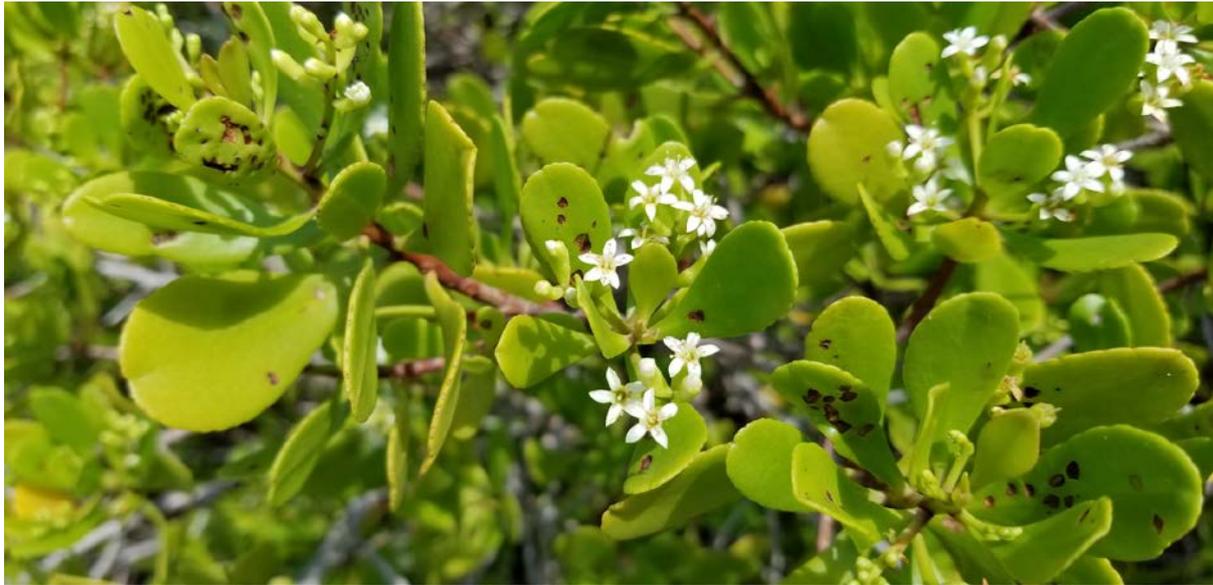
Regarding our general observations on ecology, the dominant species at Kulhudhuffushi was *Lumnitzera racemosa*. There was also evidence of healthy *L. racemosa* colonizing on the dredged spoil for the runway that ended up flowing adjacent to the existing stand on the south side. The mangrove generally were in good health, with little leaf discoloration (reflecting stress in some mangrove species) and a moderate amount of insect damage to leaves; some individuals were flowering. This was encouraging, as our earlier communications suggested that the mangrove vegetation was at risk due to the altered hydrological conditions.

*Lumnitzera racemosa in flower at Kulhudhuffushi.*

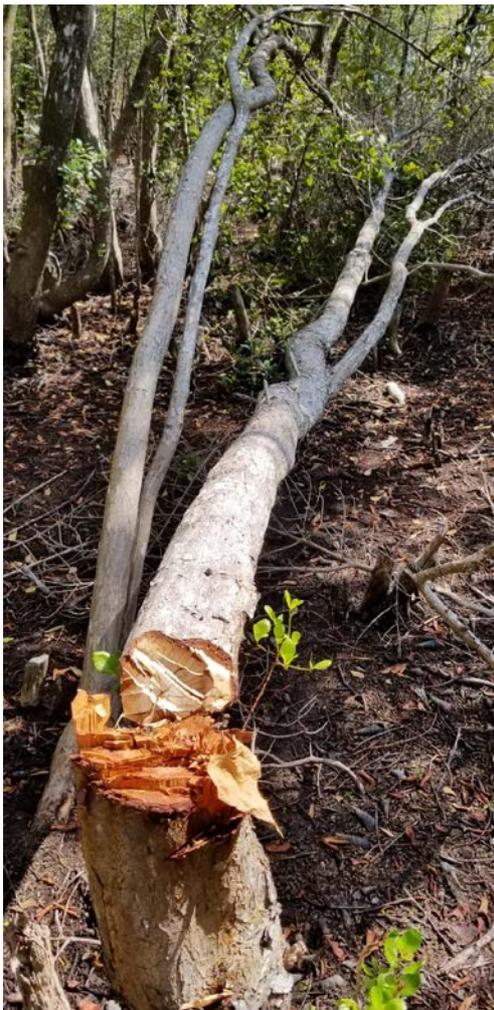
- Dumping of waste is a very serious issue
- Illegal cutting: recent as well as historical cutting of mature *Lumnitzera racemosa* trees was evident in the forest (Fig. Y). While it is not clear who felled the trees and for what purpose, continued cutting would pose a strong threat to the long-term viability of the forest

*A mature Lumnitzera racemosa tree found cut down very recently before our field visit*

Trash management and enforcement is needed.

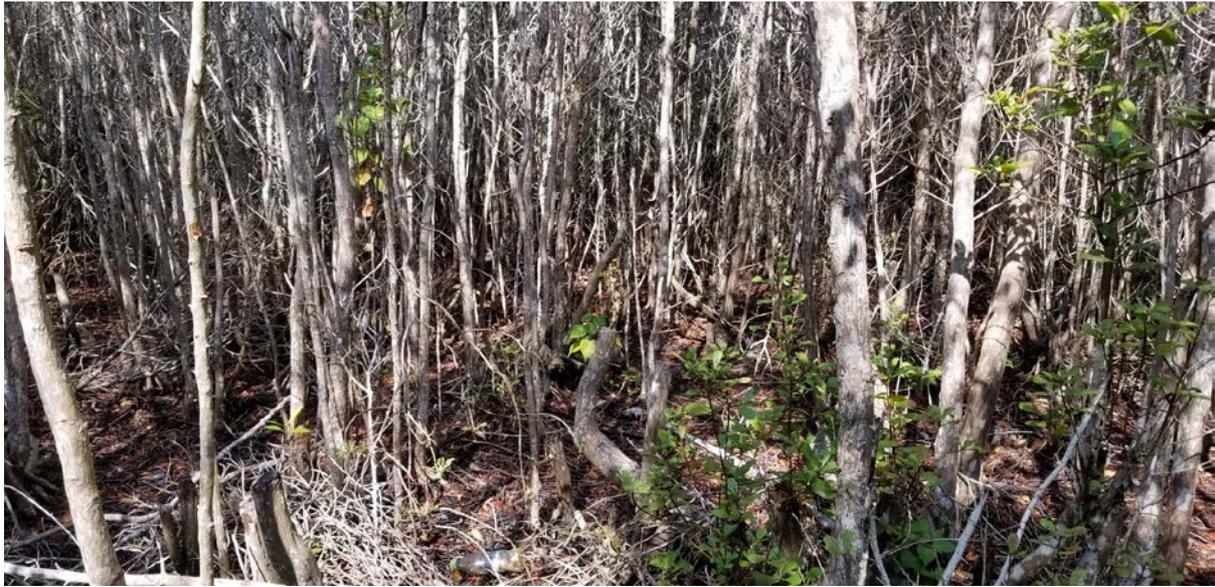
*There was evidence of significant past cutting of trees in the mangrove forest*

There were cut stems and stumps from previous mangrove cutting, especially within the southern portion of the mangrove forest, as well as evidence of recent cutting of large healthy *Lumnitzera racemosa* with the chopped tree laying on the ground awaiting removal. Other mangrove species, including *Rhizophora mucronata* (this species could have been misidentified in previous studies – probably *R. stylosa*) and *Bruguiera cylindrica*.

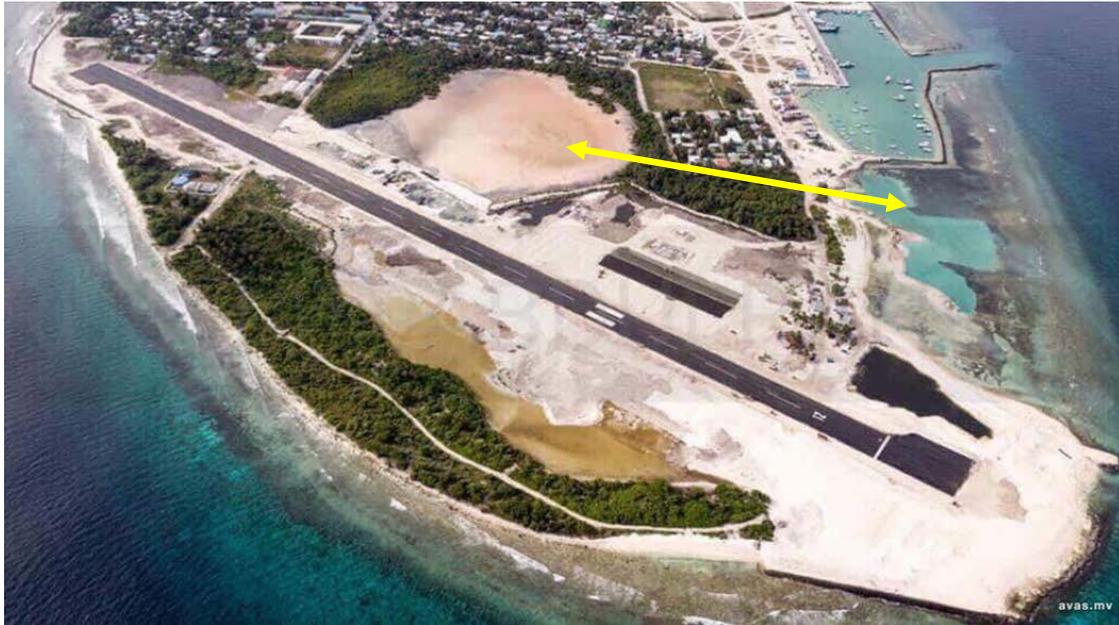
*A channel of ~300m (yellow arrow in photo above – exact position to be determined) connecting the ocean and the lagoon could help restore some hydrologic connectivity and reduce many of the management concerns at Kulhudhuffushi*

A new channel connecting the southern lagoon to the ocean may help restored tidal connectivity and help rehabilitate the mangroves into a functional wetland. A rough estimation suggested that a channel of at least ~300 m will be necessary. Given that the tidal range is only ~1 m, and the lagoon's elevation is considerably higher than that of the beach, any channel constructed will need a sluice gate (see option 3) to enable water level and flushing control. The team has conducted a quick survey of the forest area between the southern lagoon and the beach. The forest is a mixture of mangrove and beach forest species. If this option is taken, the channel should be constructed along the road, not

through the existing mangrove area, for easier construction and less damage to the mangrove forest. This option was also suggested by the Island Council.
